HABITAT MANAGEMENT PLAN (Volume 2 of 2)

Birrigan Iluka Beach
Hickey Street, Iluka
Lot 99 on DP823635

A Report Prepared for
Steven Holdings Pty Ltd

JULY 2020

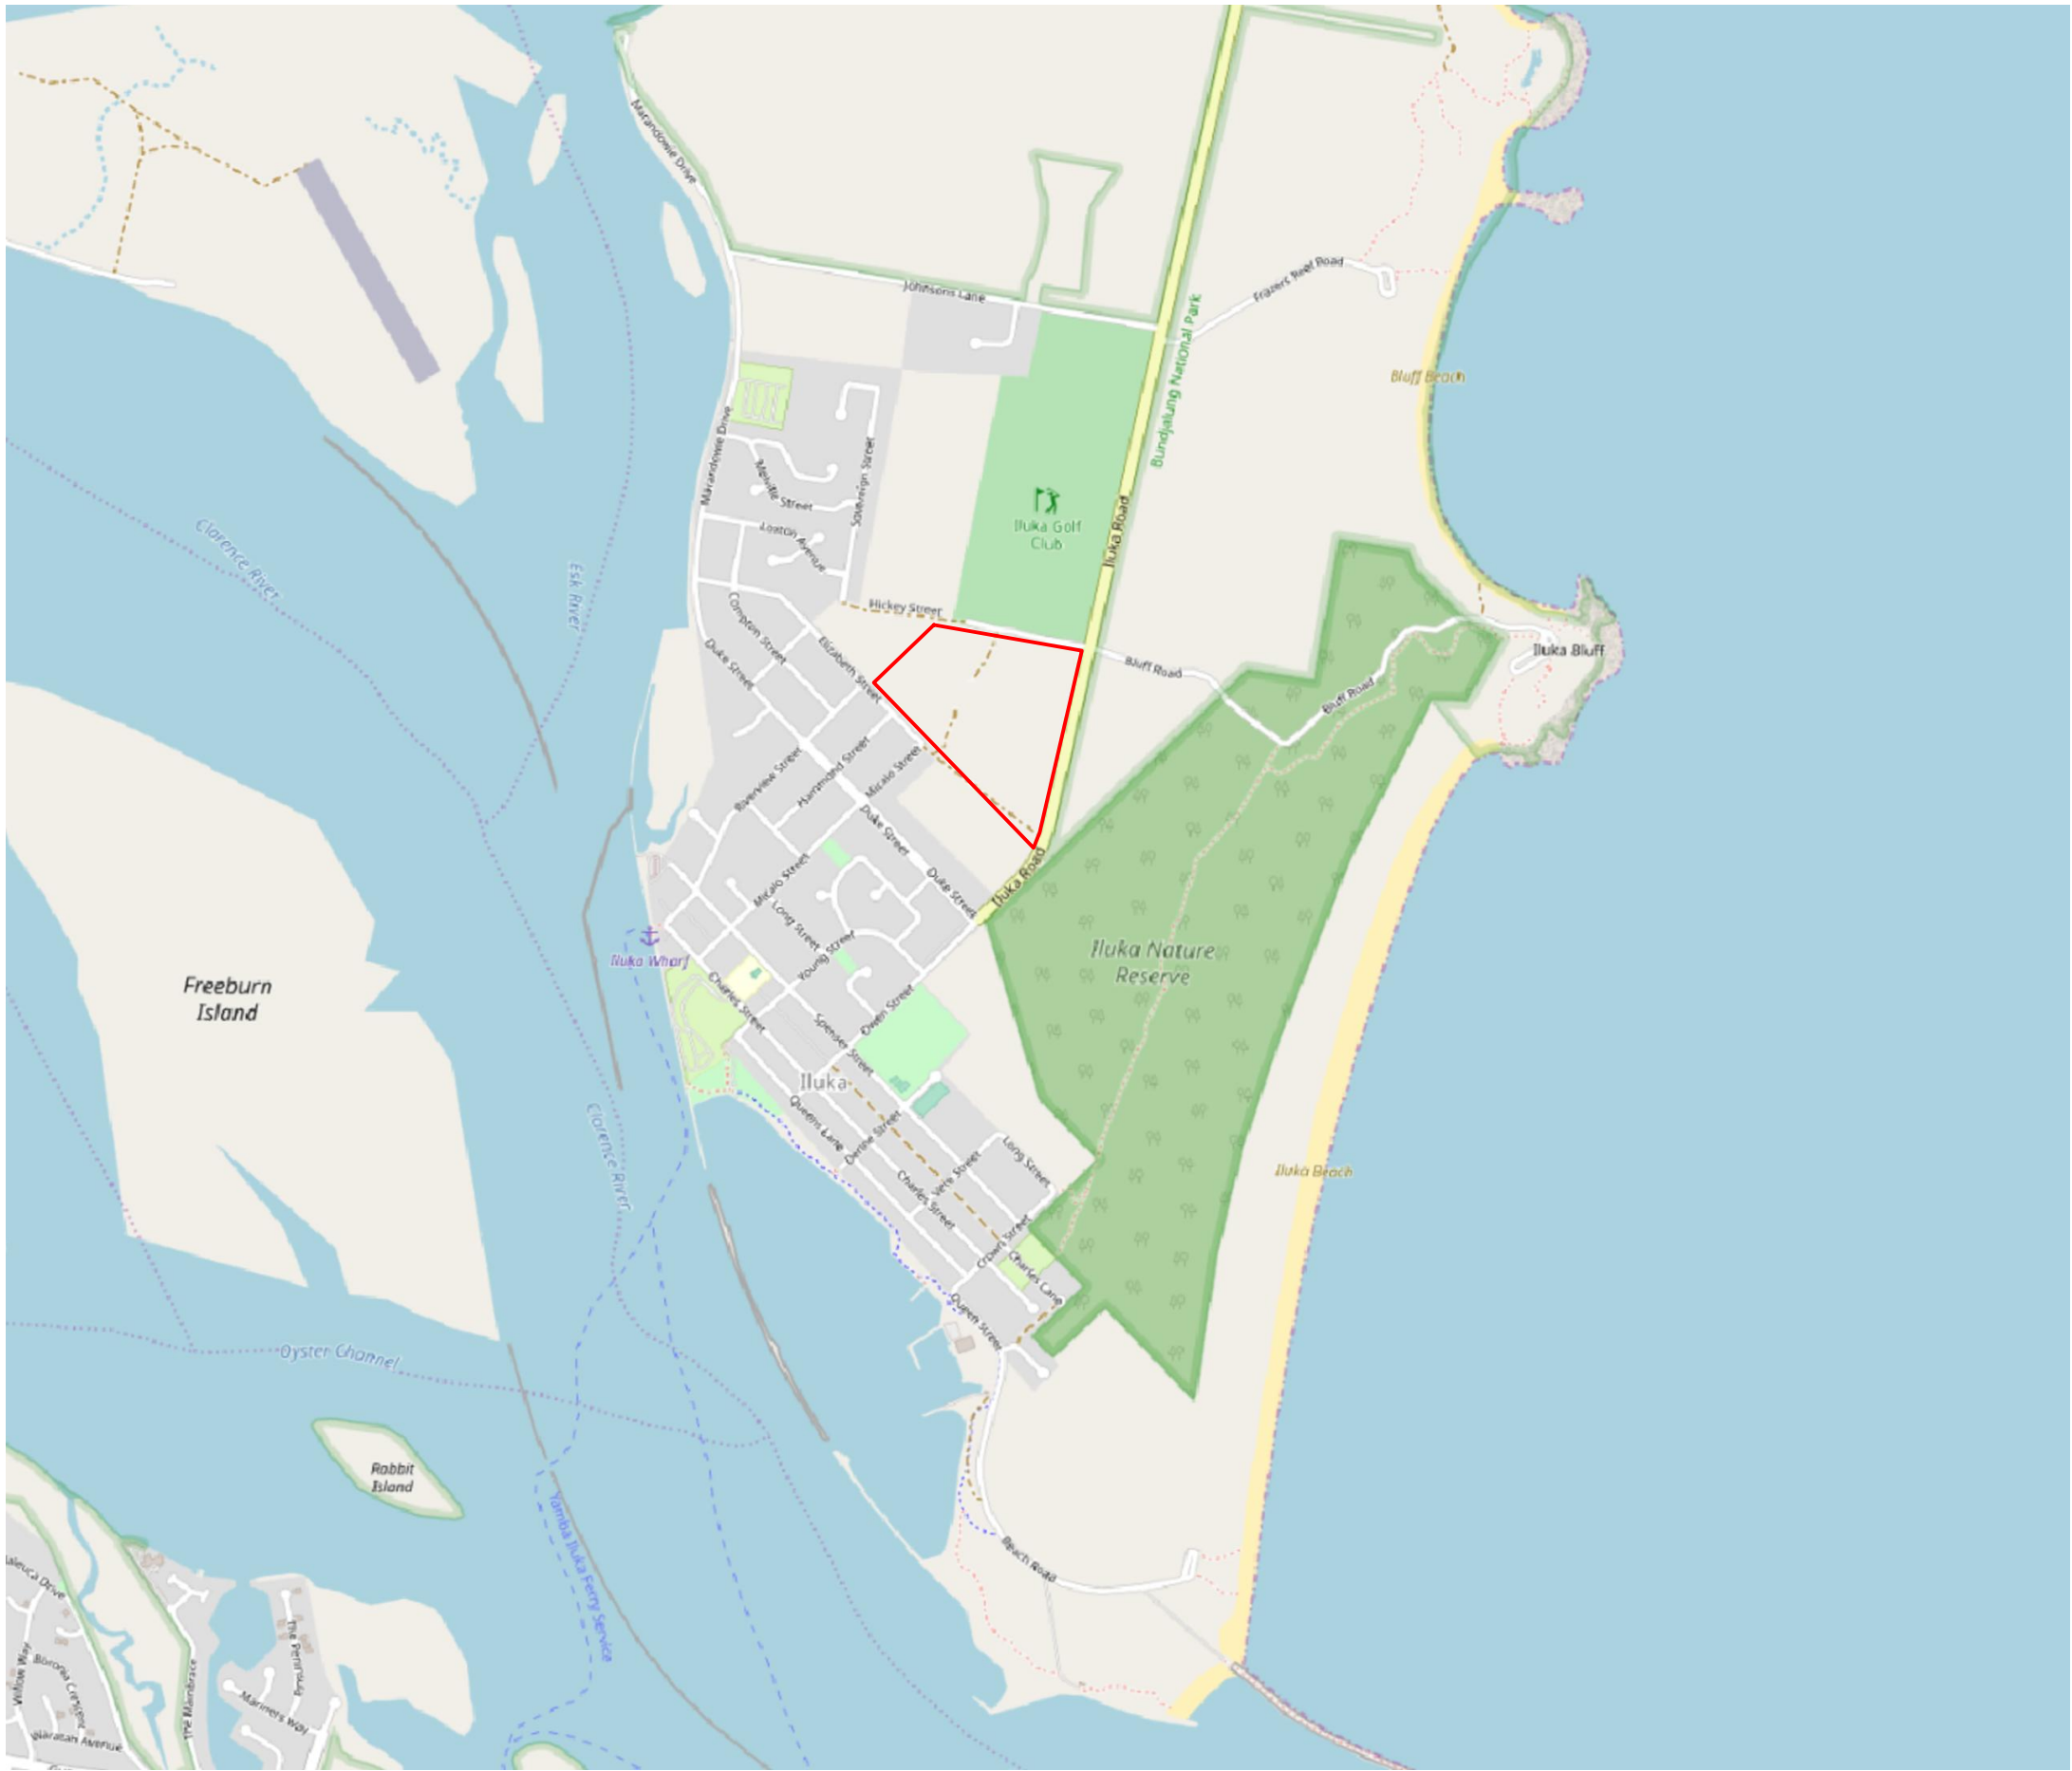
SOURCE: OneCollective - Masterplan (191113 CVC Approved Plans - Extract.pdf)	CLIENT Ocean Park Consulting Pty Ltd	FIGURE 1	TITLE APPROVED MASTER PLAN
SCALE: 1 : 2500 @ A3	PROJECT Baseline Koala Monitoring Report Birrigan Estate Lot 99 on DP823635, Hickey Street, Iluka NSW Clarence Valley Council LGA		
<div>JWA PTY LTD Ecological Consultants</div>	PREPARED: BW DATE: 02 June 2020 FILE: N202001_SAT_20200302.dwg

JWA Pty Ltd have been engaged by The Stephens Group Pty Ltd to undertake baseline monitoring for the koala (*Phascolarctos cinereus*) population at the Birrigan Iluka Beach development site, located at Hickey Street, Iluka - formally described as Lot 99 on DP823635. The Birrigan Iluka Beach development is an approved 141 lot community scheme subdivision over the subject land (**FIGURE 1**).

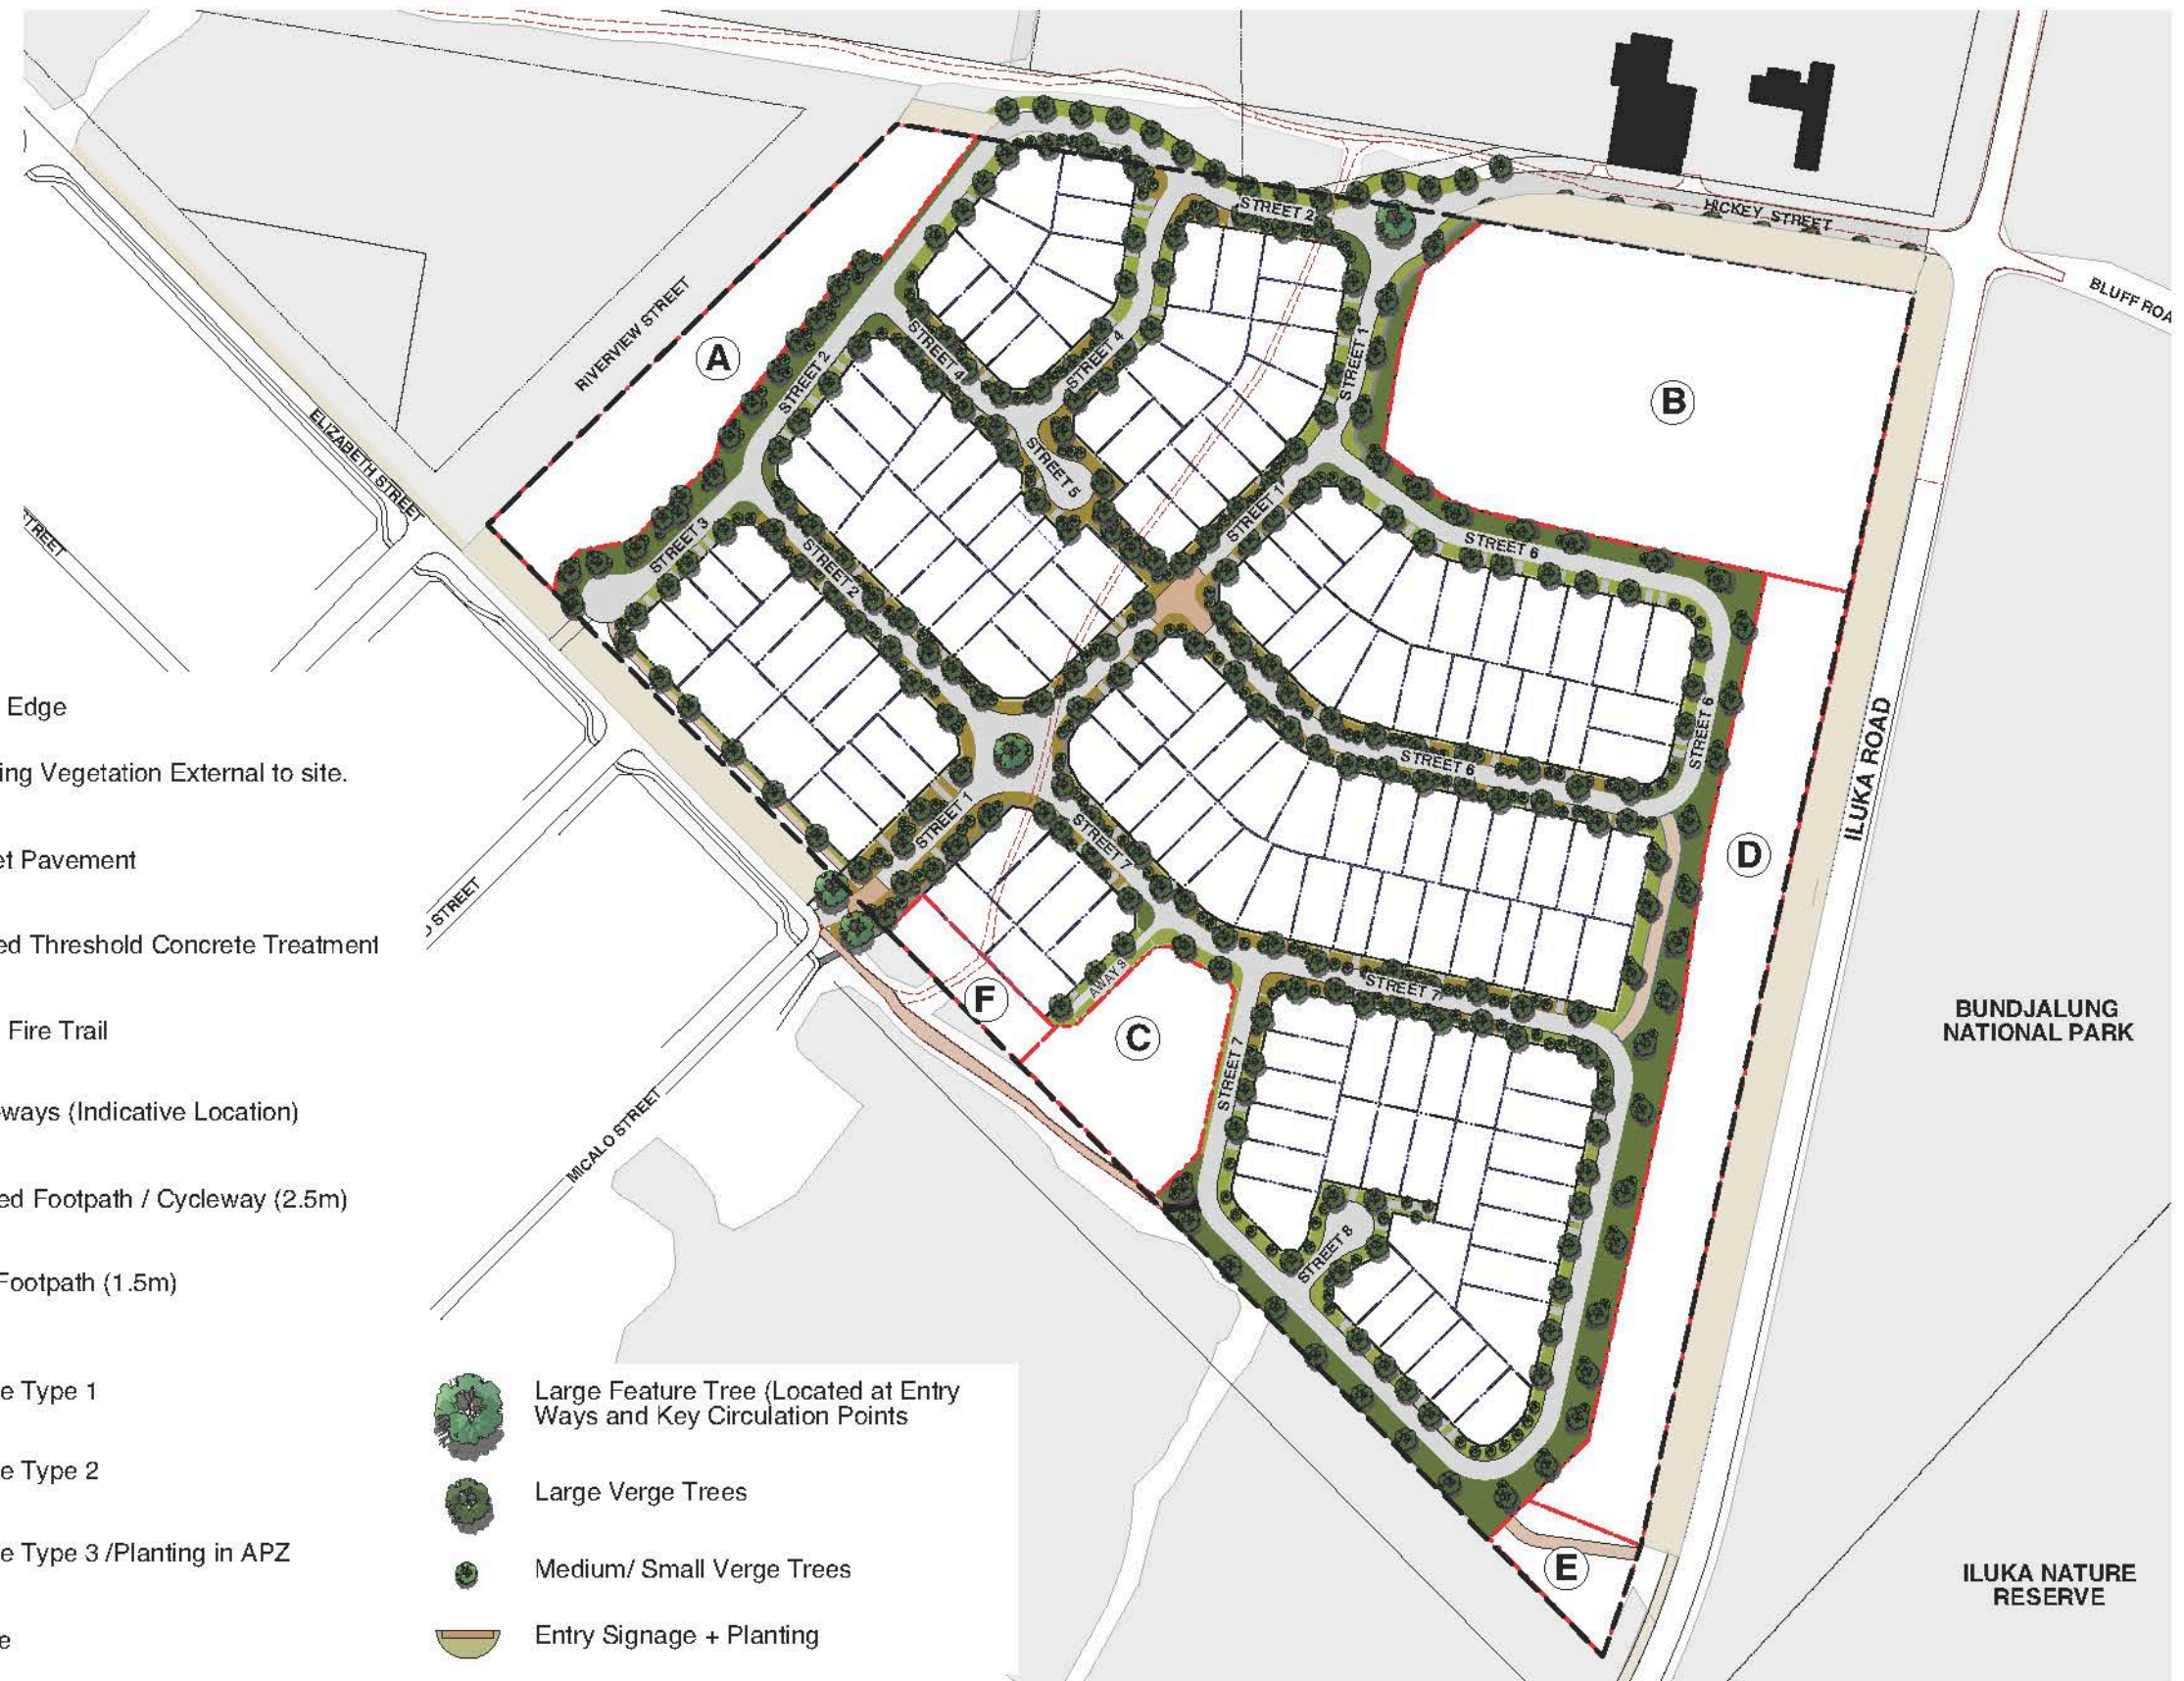
Street Hierarchy and street treatment are illustrated adjacent.

Three key street types are proposed for the sub-division

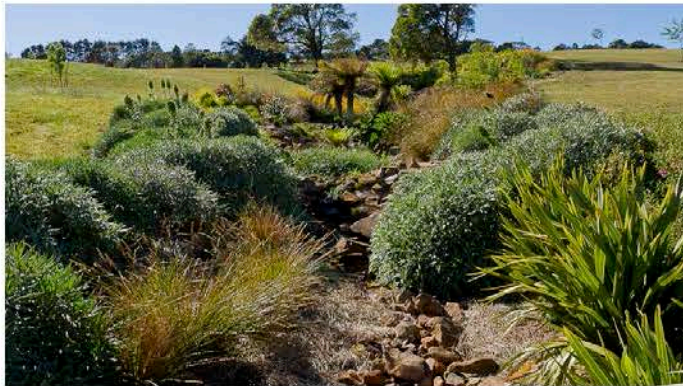
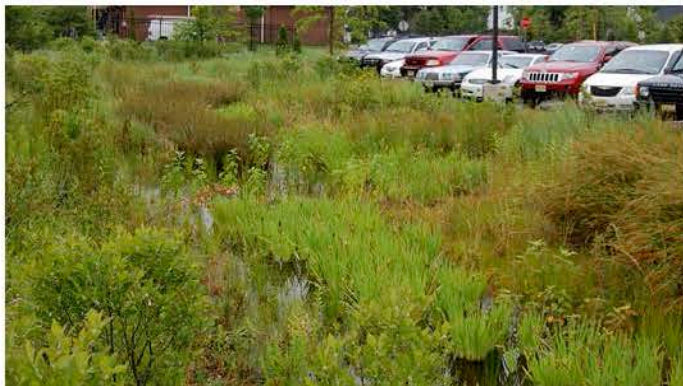
Images show rocks, sandy edges and habitat options within swales to support fauna movement and shelter as well as WSUD benefits.

Habitat Swales with endemic planting/food trees on Habitat Corridor and Link Street (outside APZ).

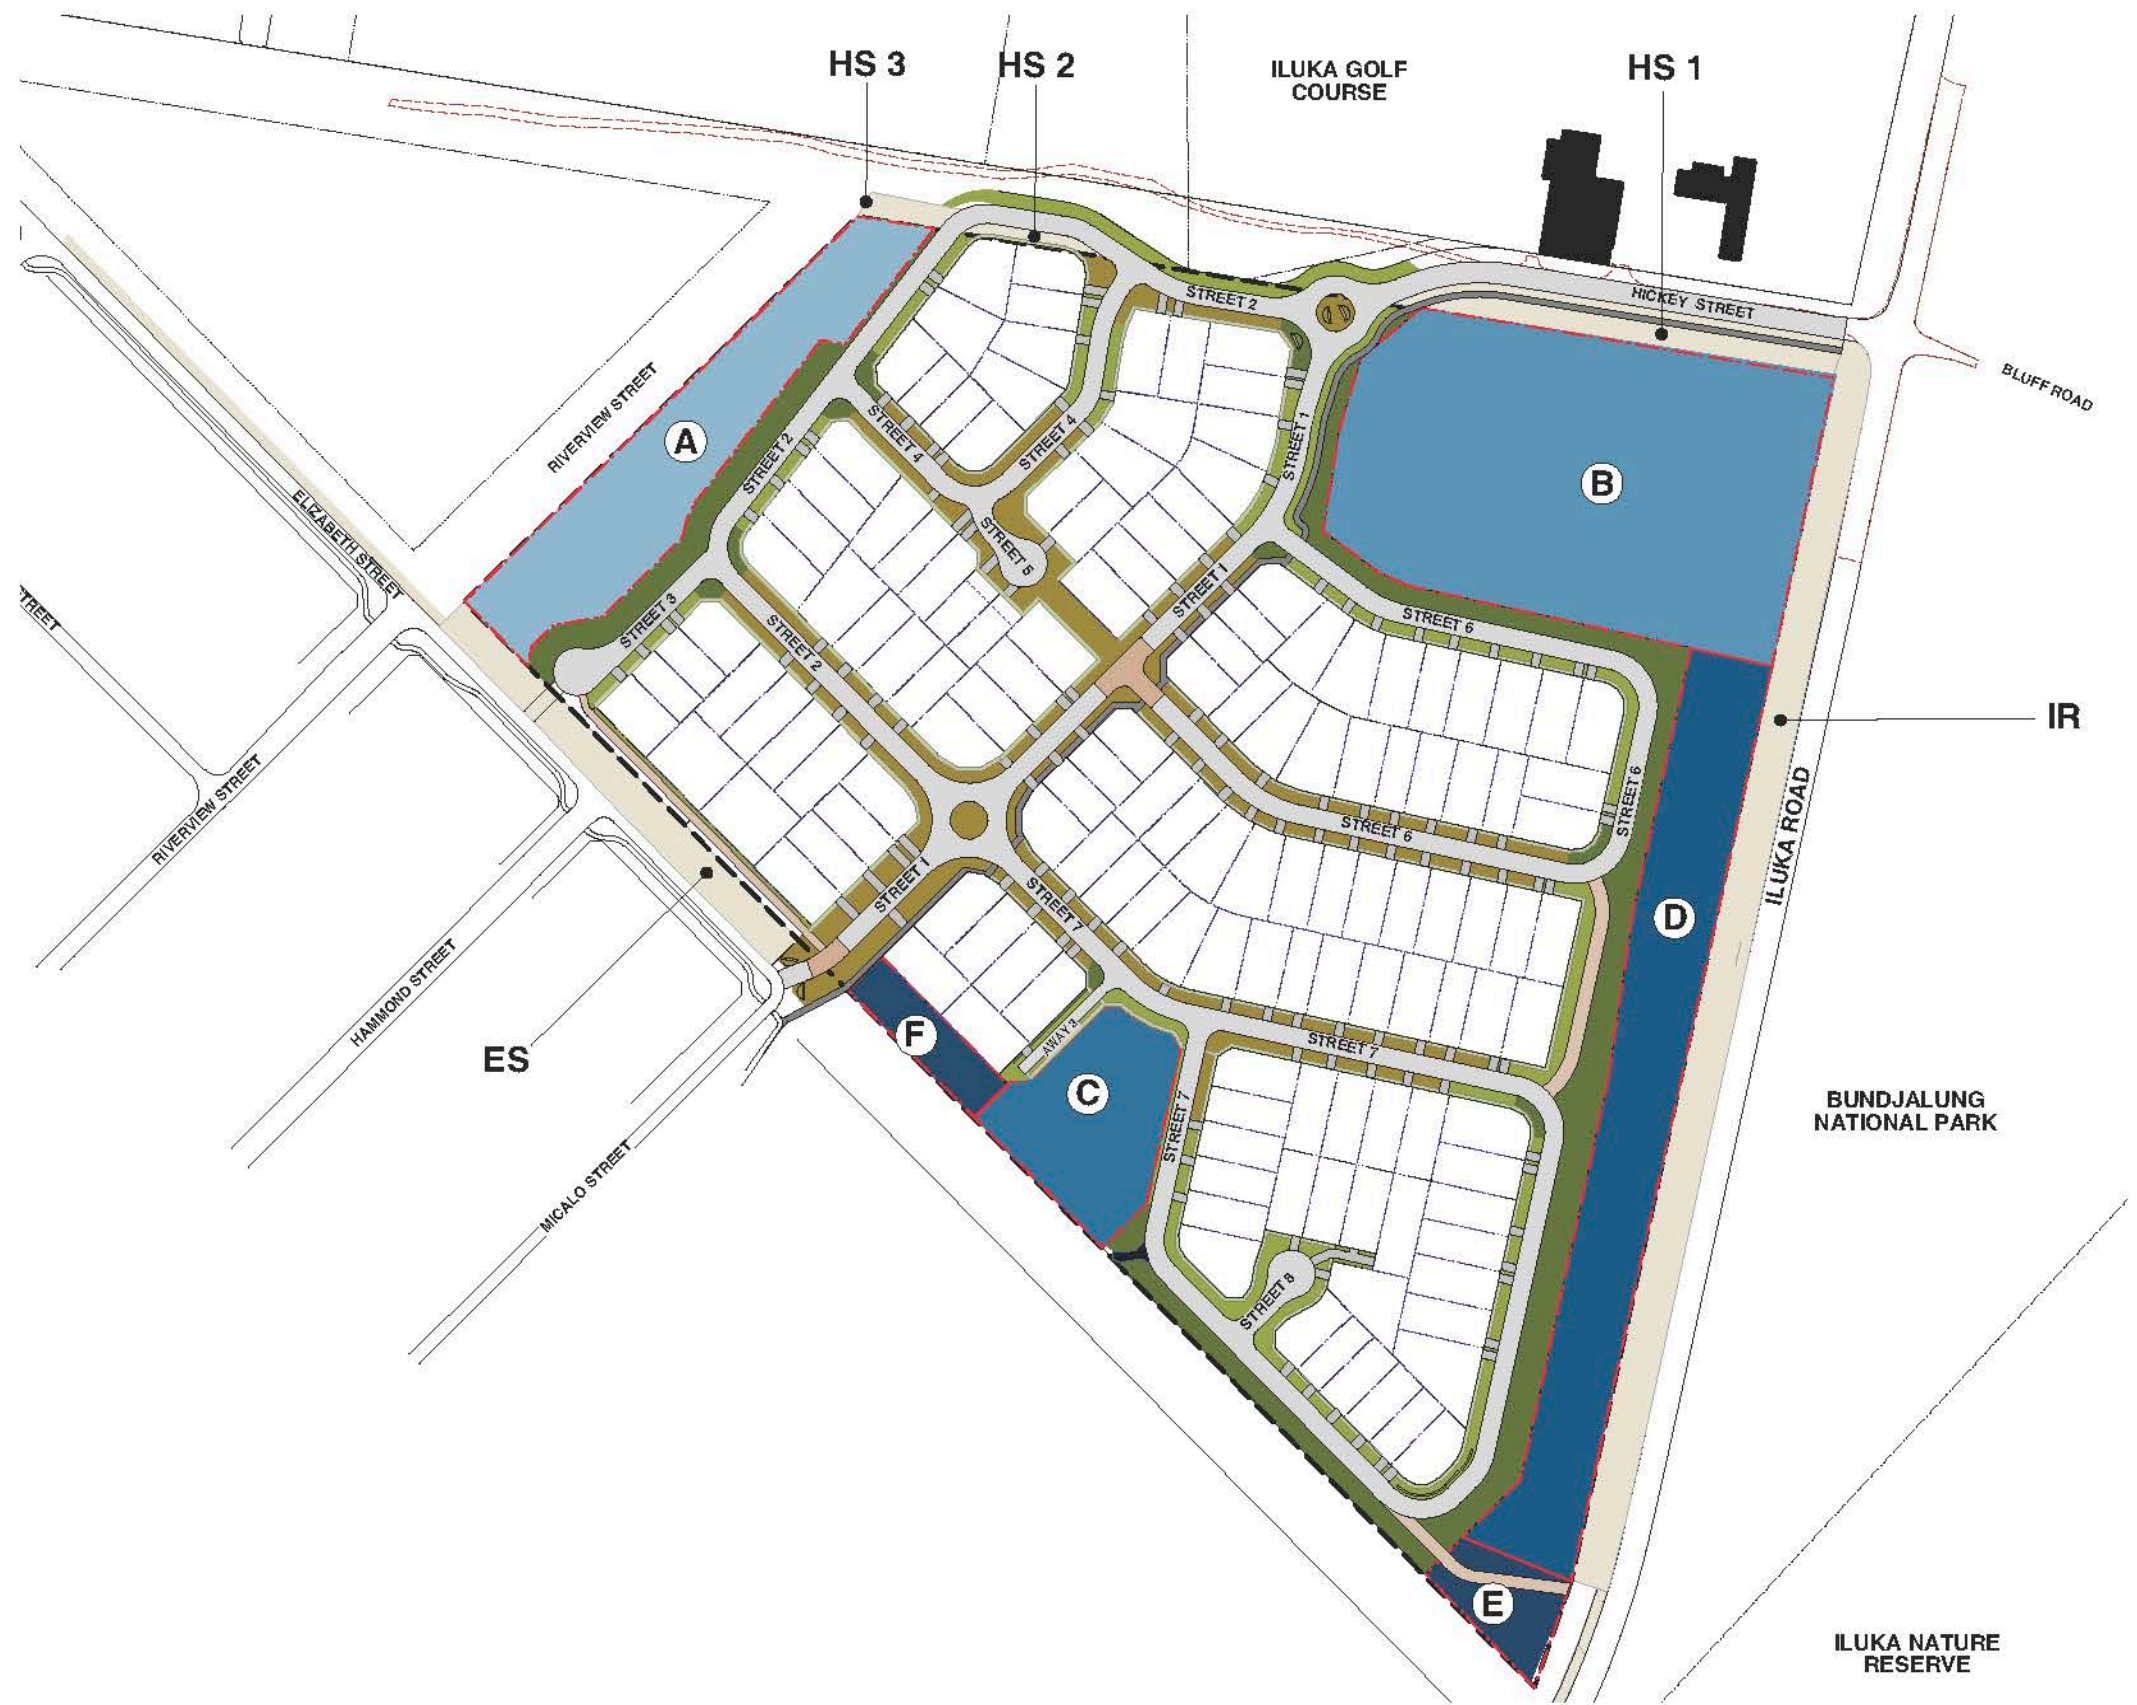
Share Path

Running north-south and connected to the existing cycle network a 2500mm share path is proposed. In addition to the works proposed within the subdivision a refuge is proposed on Iluka Road north of the subdivision.

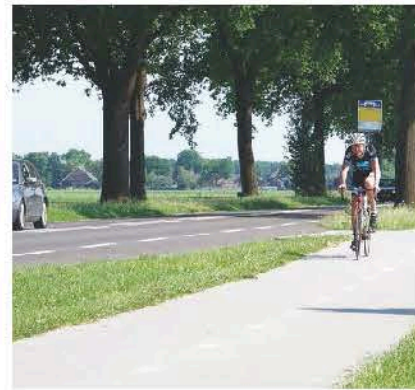
2500MM Share Path through subdivision

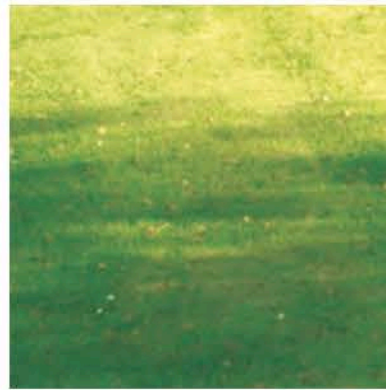
1500mm Turf Access way through subdivision on Property

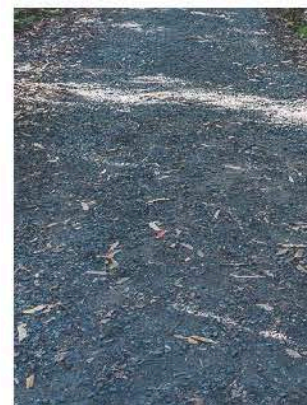
Sealed Bush-fire Trail suitable for pedestrian access

The third access path type is along Bushfire Trail access paths which will be sealed and provide additional access throughout the subdivision.

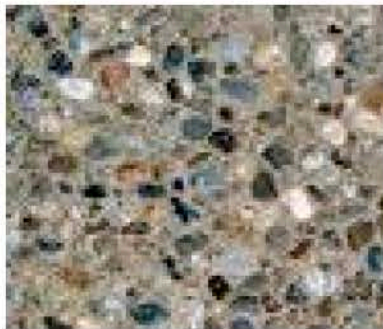
Change in paving type to slow traffic at key locations on Link Street (indicative only).

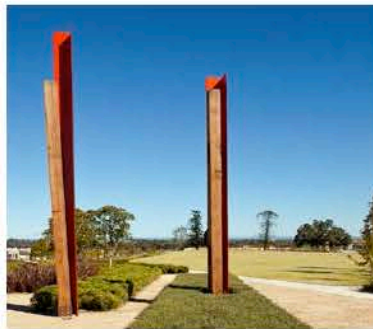
Entry Feature to future detail. Sample Image

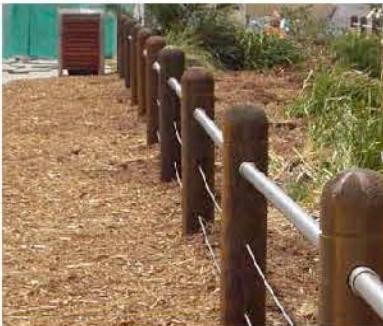
Bollard and Steel Rope on subdivision edge at key locations.

Type 2 - Subdivision Edge - Bollards and Steel Rope

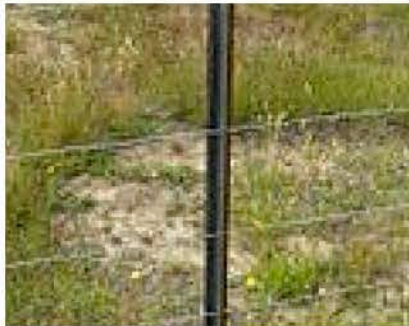
Star Pickets to define park edge

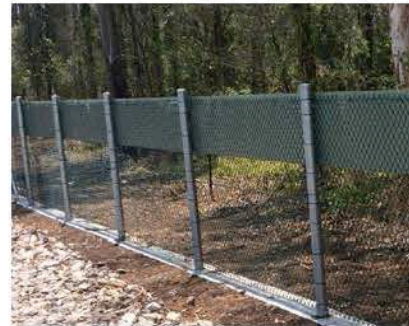
Koala Exclusion Fence

Type 3 - Fauna Sensitive - Koala climb-proof fencing located on property boundaries where owners have animals. As per the adjacent plan this is located outside of the 6m set-back to ensure the free flow of animals along the road verges and within the front 6m of each property.

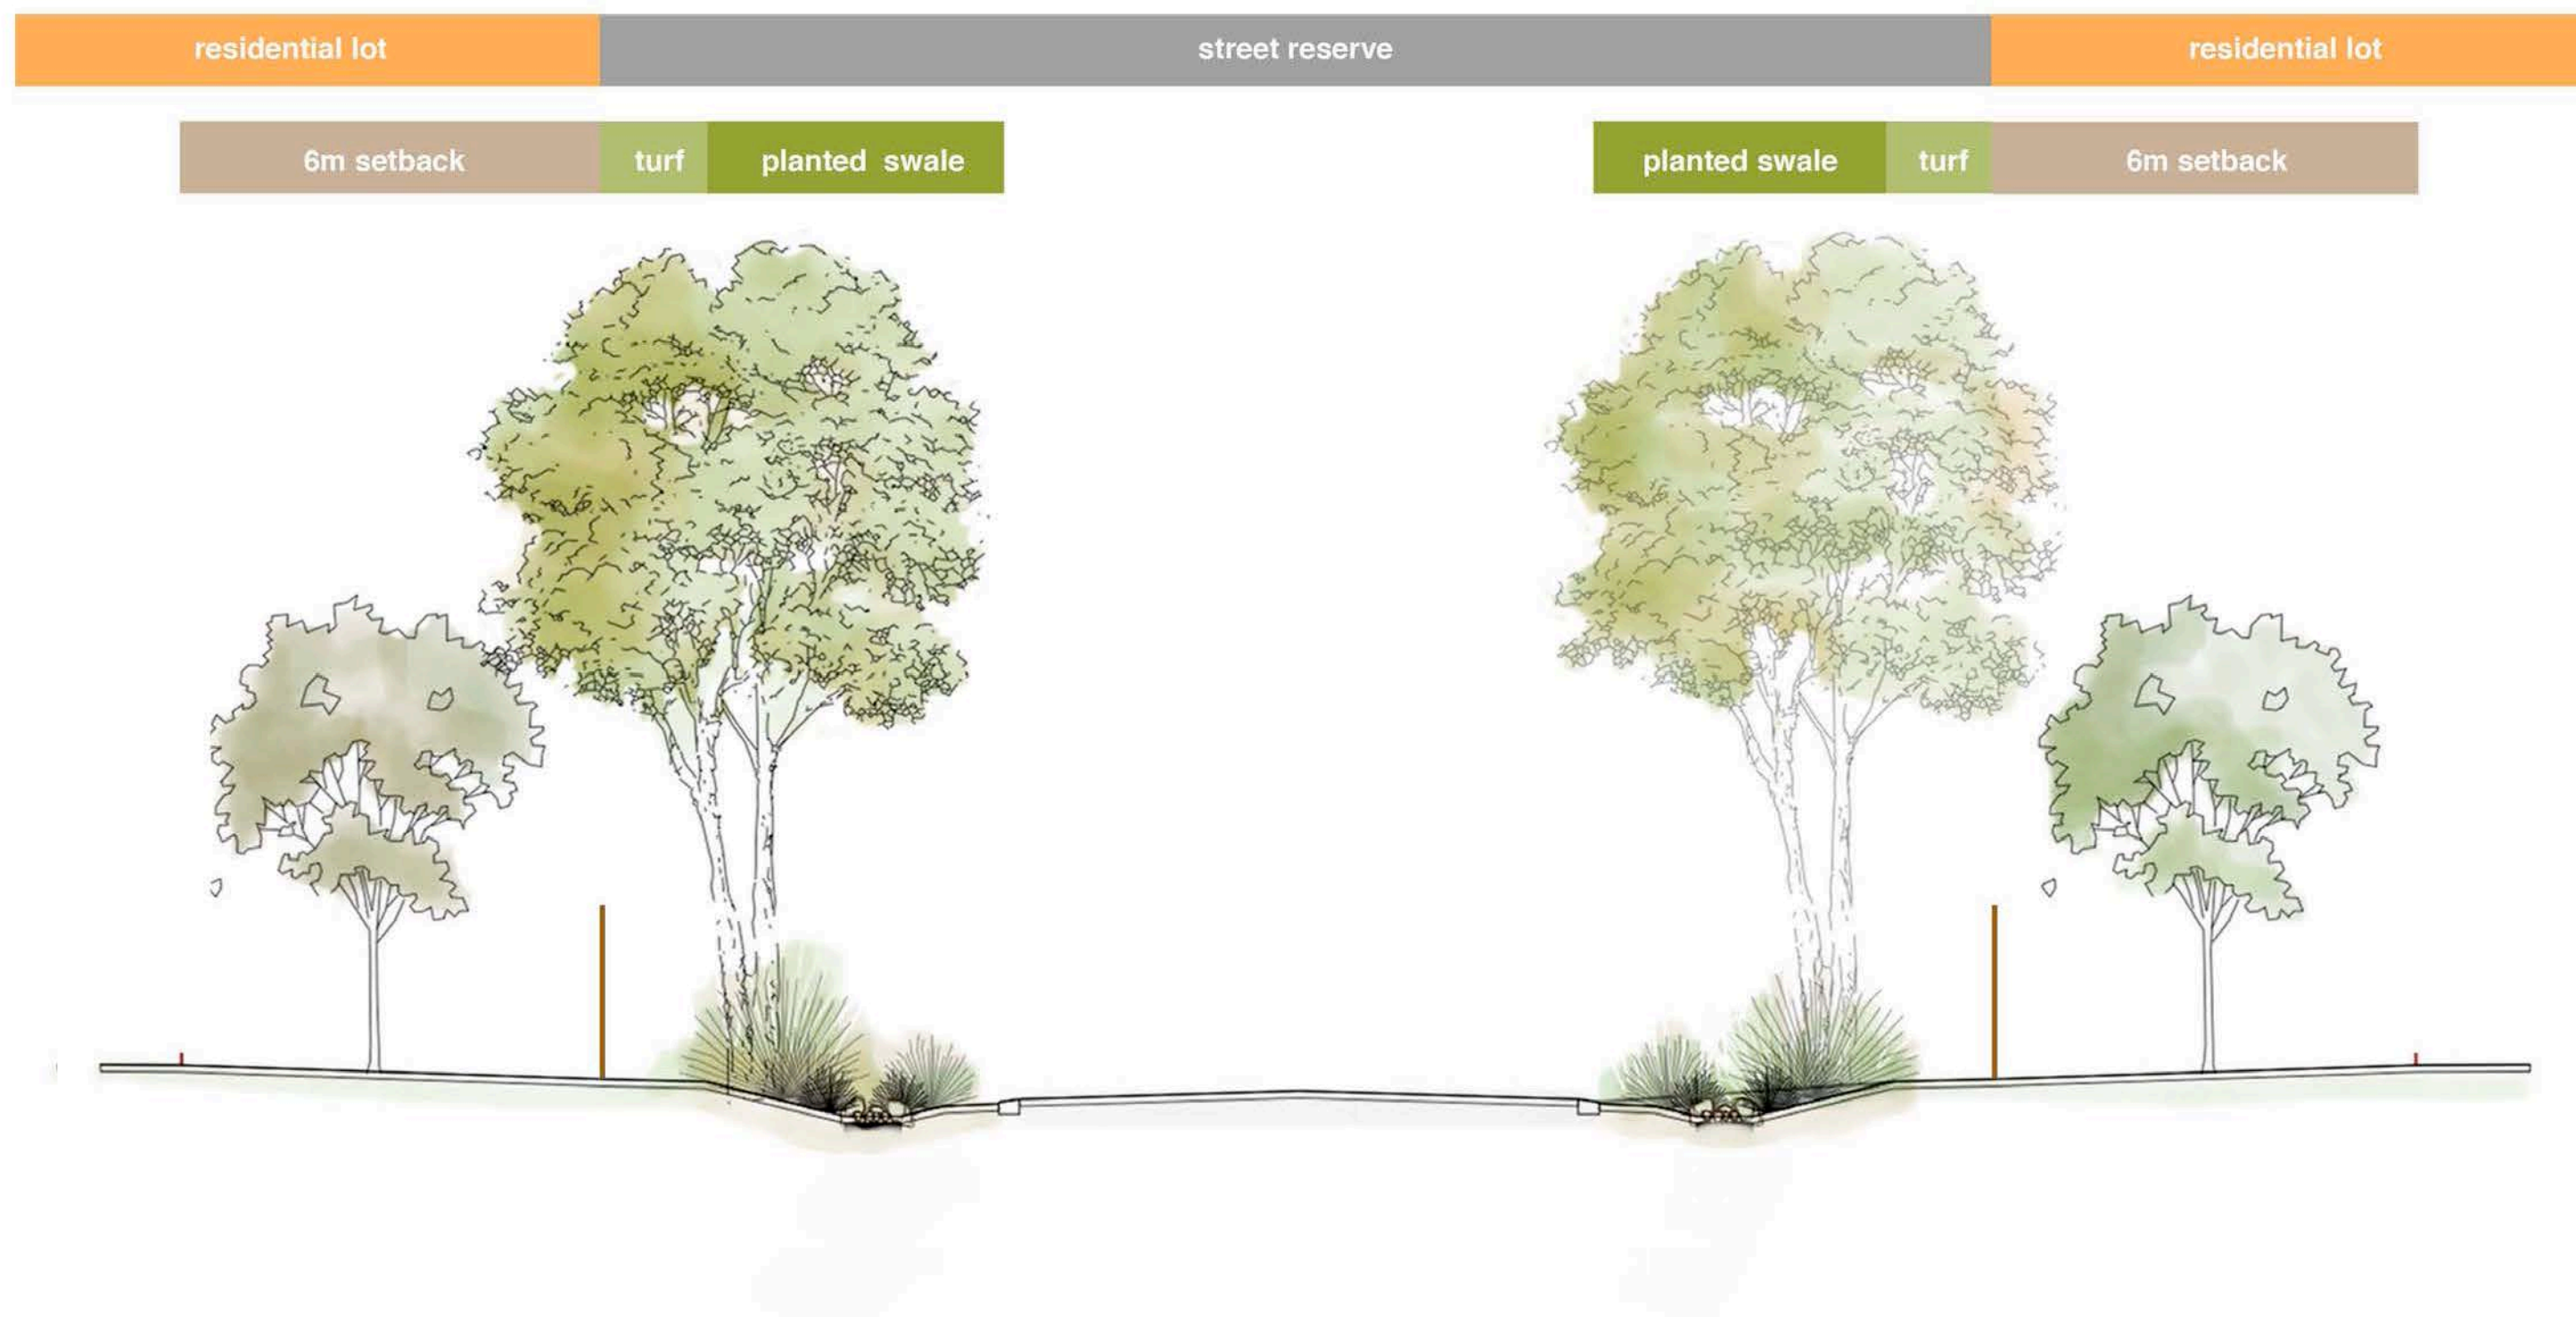
1 6000mm Building Setback
Planting by owners to include small tree and max 25% lawn. All mass planting to be derived from future species list in Design Guidelines. Setback provides additional habitat opportunities across the site.

Tree Planting in set-back by owners to future Design Guidelines. Contribute to overall opportunities for habitat across the site.

2 WSUD - Planted Swales Type 1
Planting in swales to provide opportunity for water treatment. Simplified species mix to provide fully structured community -groundcovers, shrubs and trees. Includes species suitable for temporary inundation and periods of dry. Rock lined base to reduce erosion and improve infiltration.

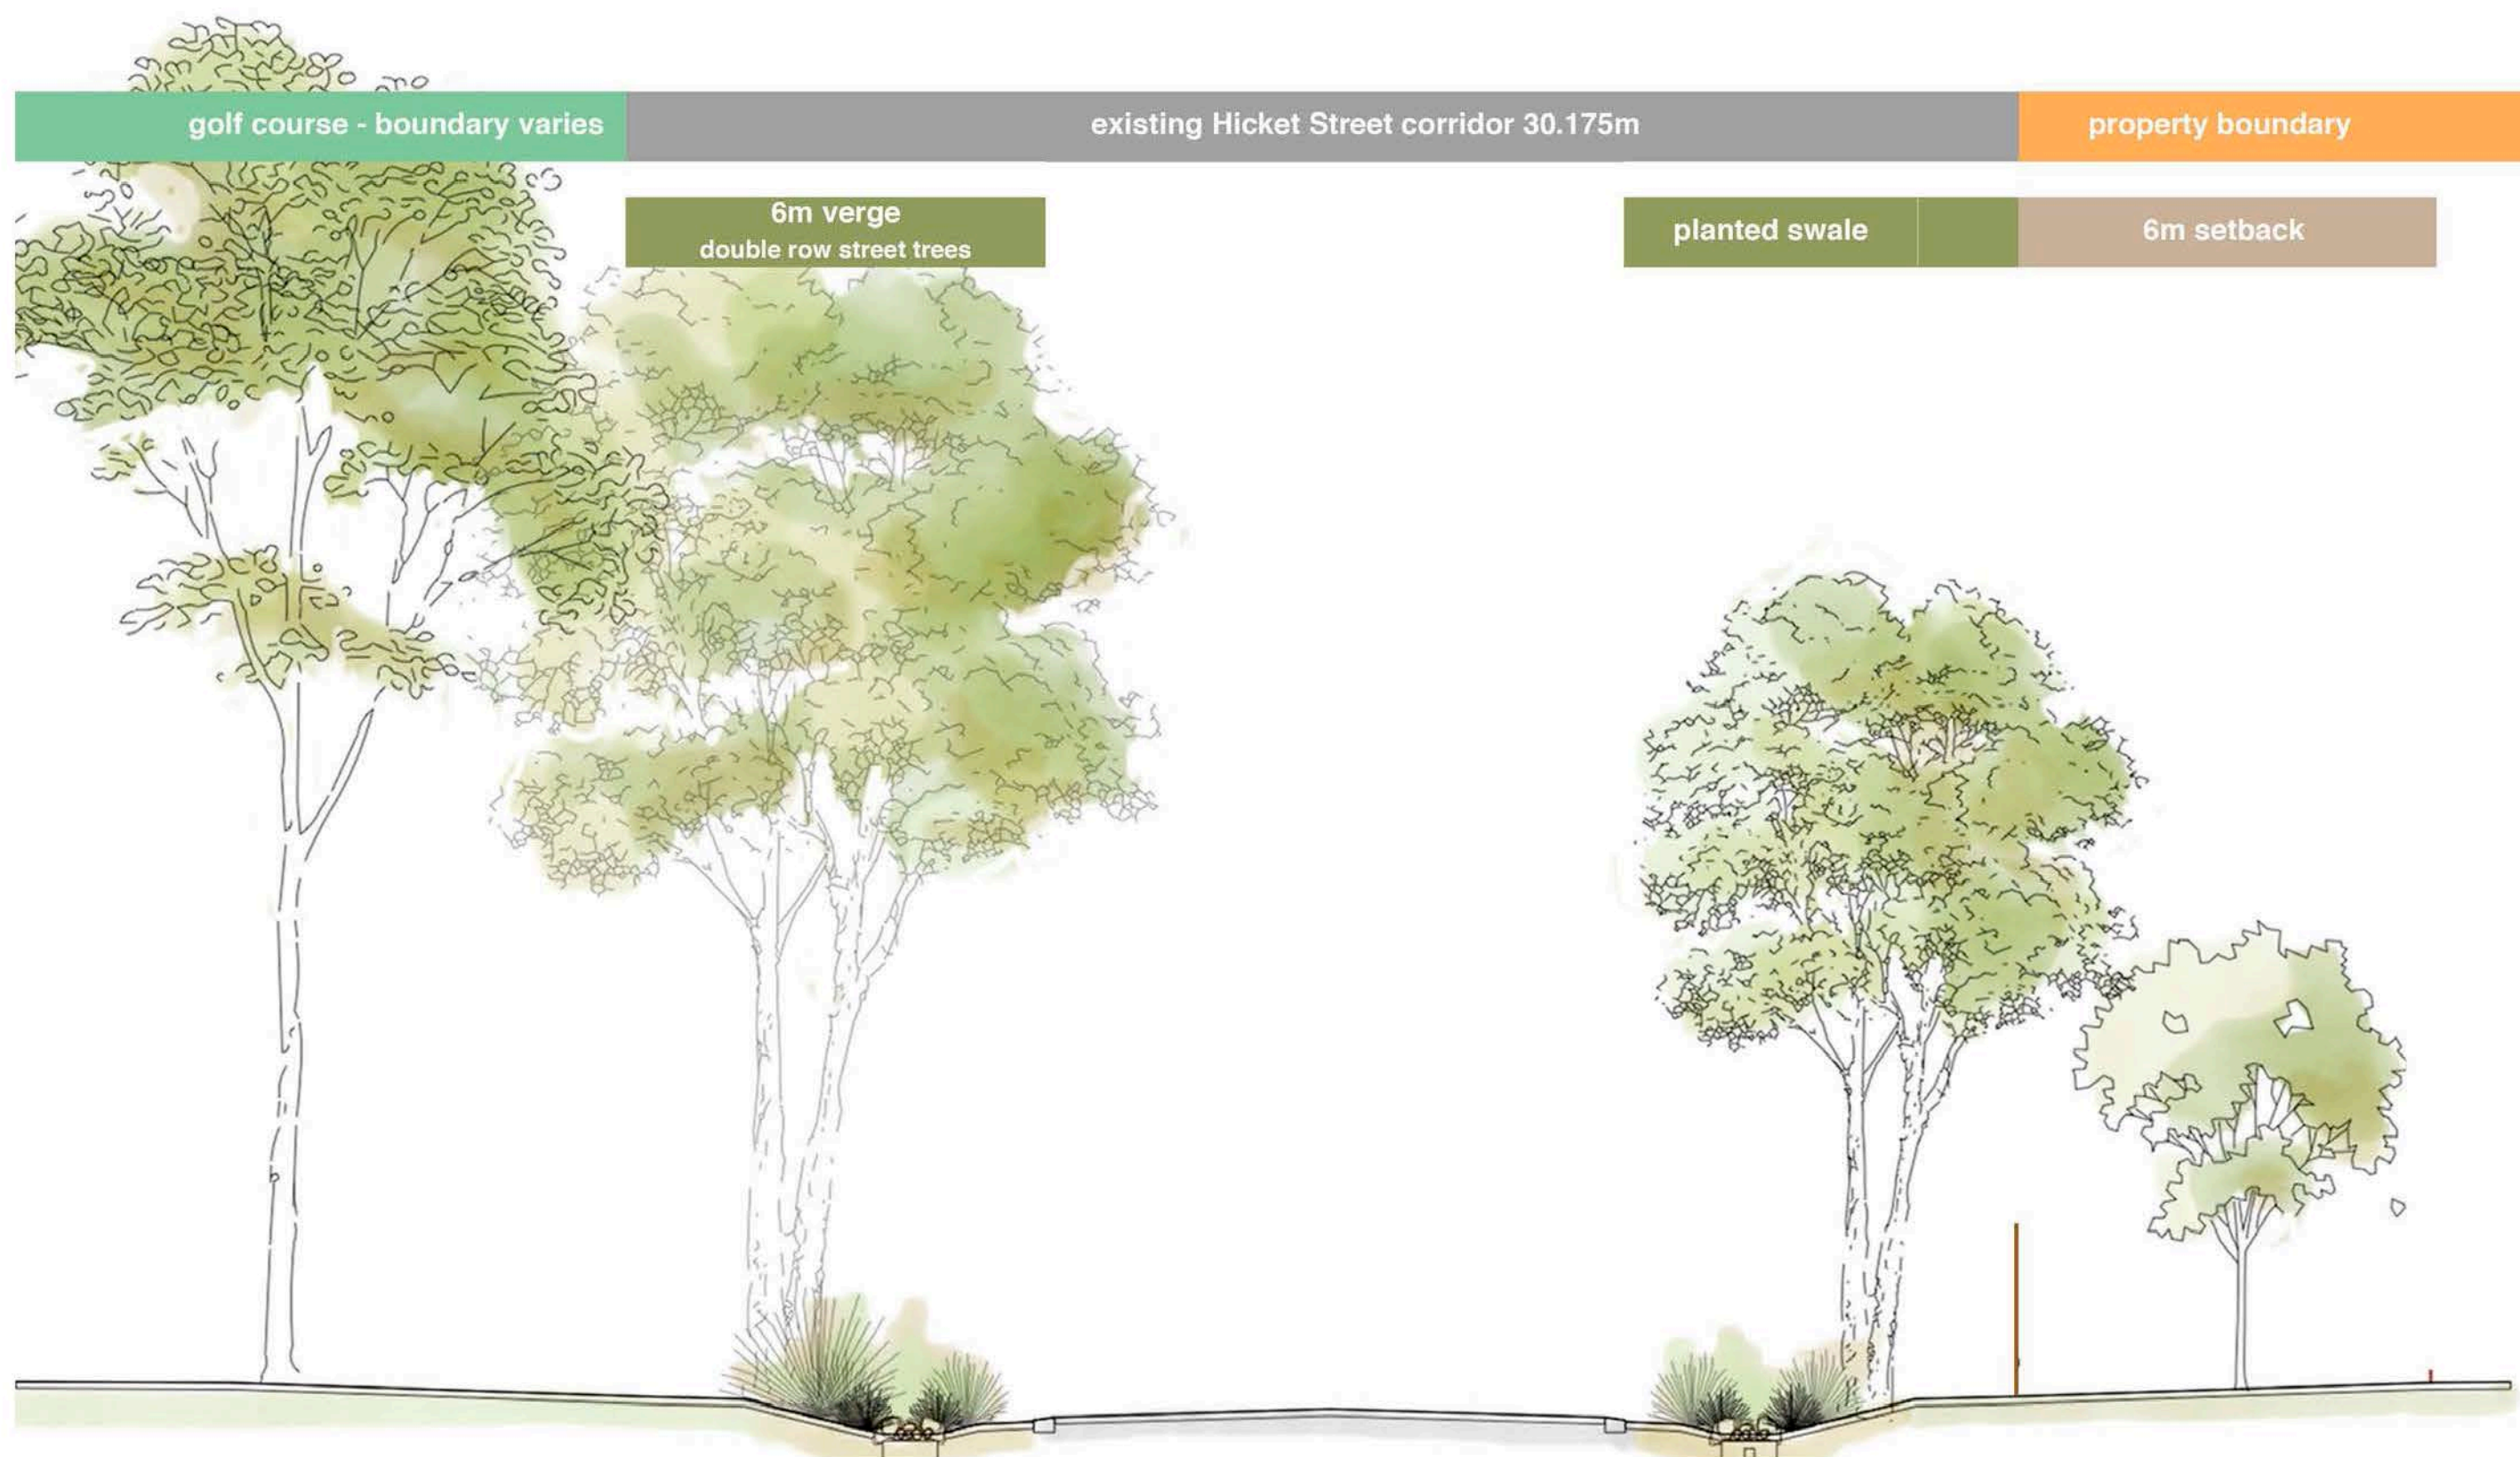
HICKEY STREET - CONCEPT DESIGN

1586 ILUKA COMMUNITY SUBDIVISION - LANDSCAPE MASTERPLAN
