Preliminary Geotechnical and Acid
Sulfate Soil Assessment:
Mardi Old Farm, 414 Old Maitland Road,
Mardi, NSW

P1706264JR03V03
March 2021

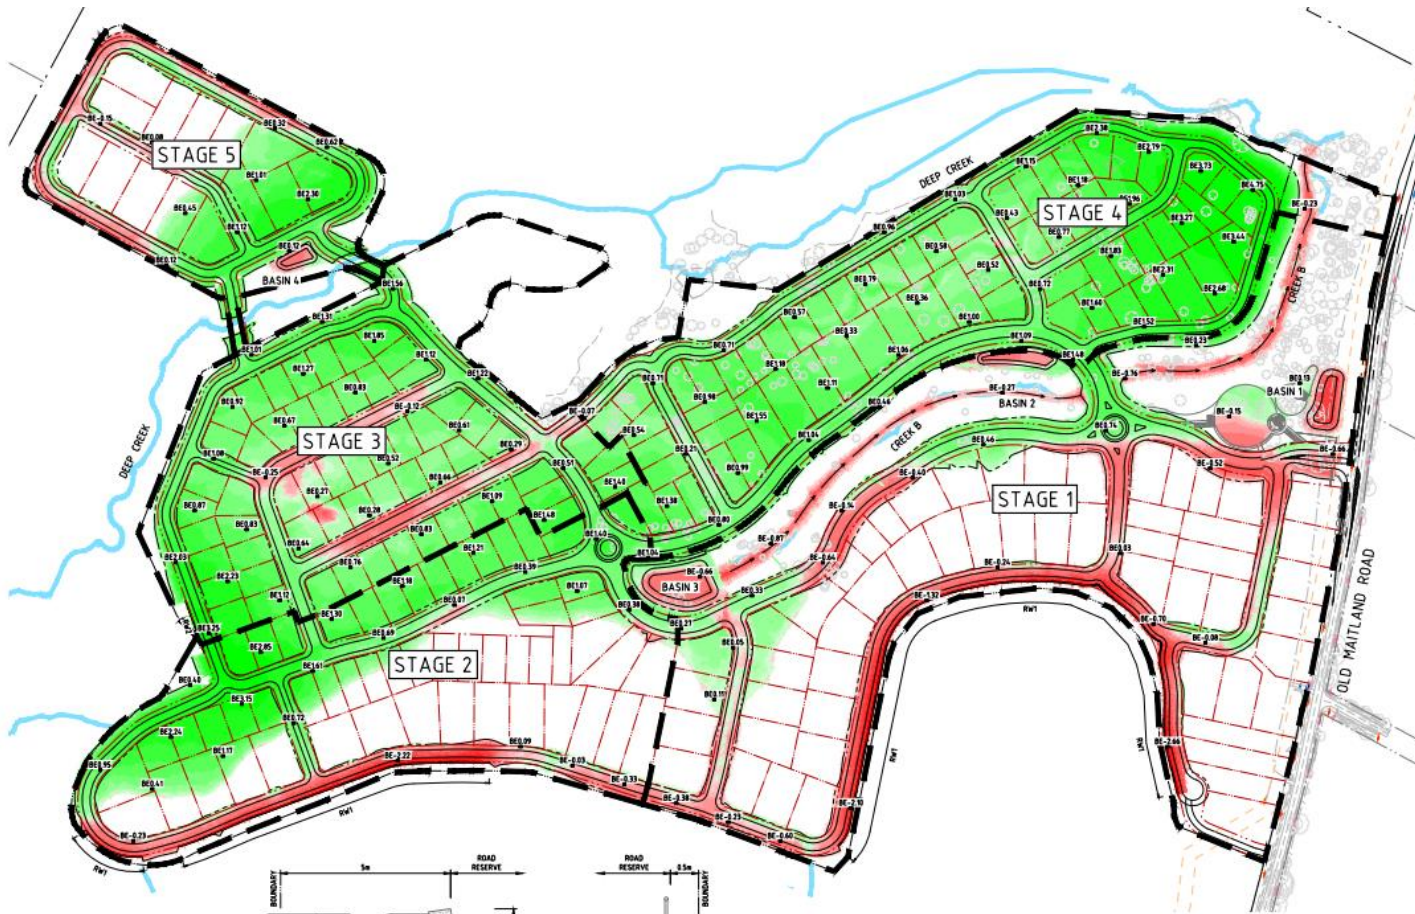
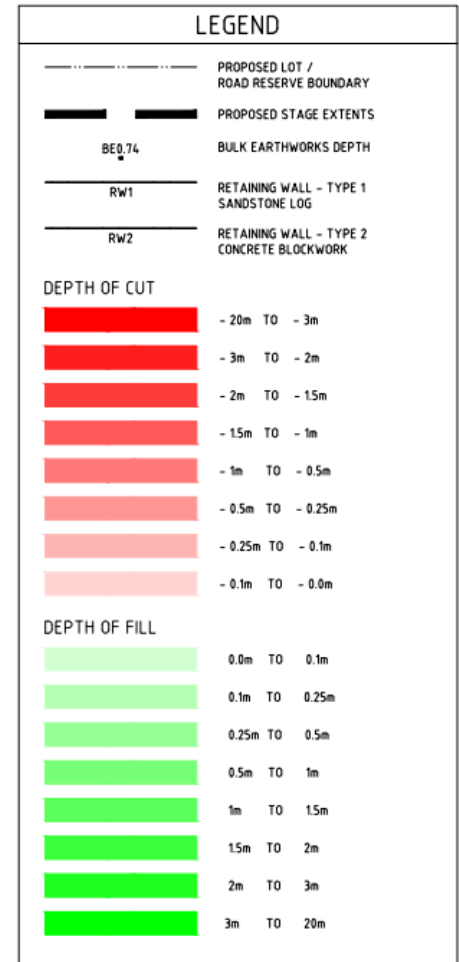
Environment Water Wastewater Geotechnical Civil Management	
CUT / FILL PLAN	
Mardi Old Farm, 414 Old Maitland Road, Mardi, NSW	
(Source: Northrop, 2021)	
Drawing:	FIGURE 3
Job No.: P1706264JR03V03

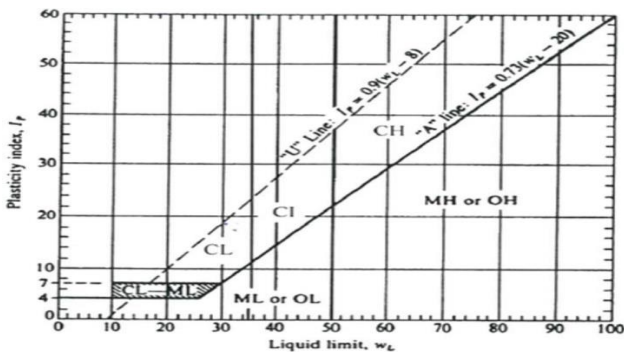
Plasticity Properties

Plasticity properties of cohesive soils can be assessed in the field by tactile properties or by laboratory procedures.
