## **ANNUAL HABITAT MONITORING REPORT**

**Birrigan Iluka Beach, Iluka  
Lot 99 on DP823635 (Parent Lot)**

A Report Prepared for  
The Stephens Group Pty Ltd

NOVEMBER 2021

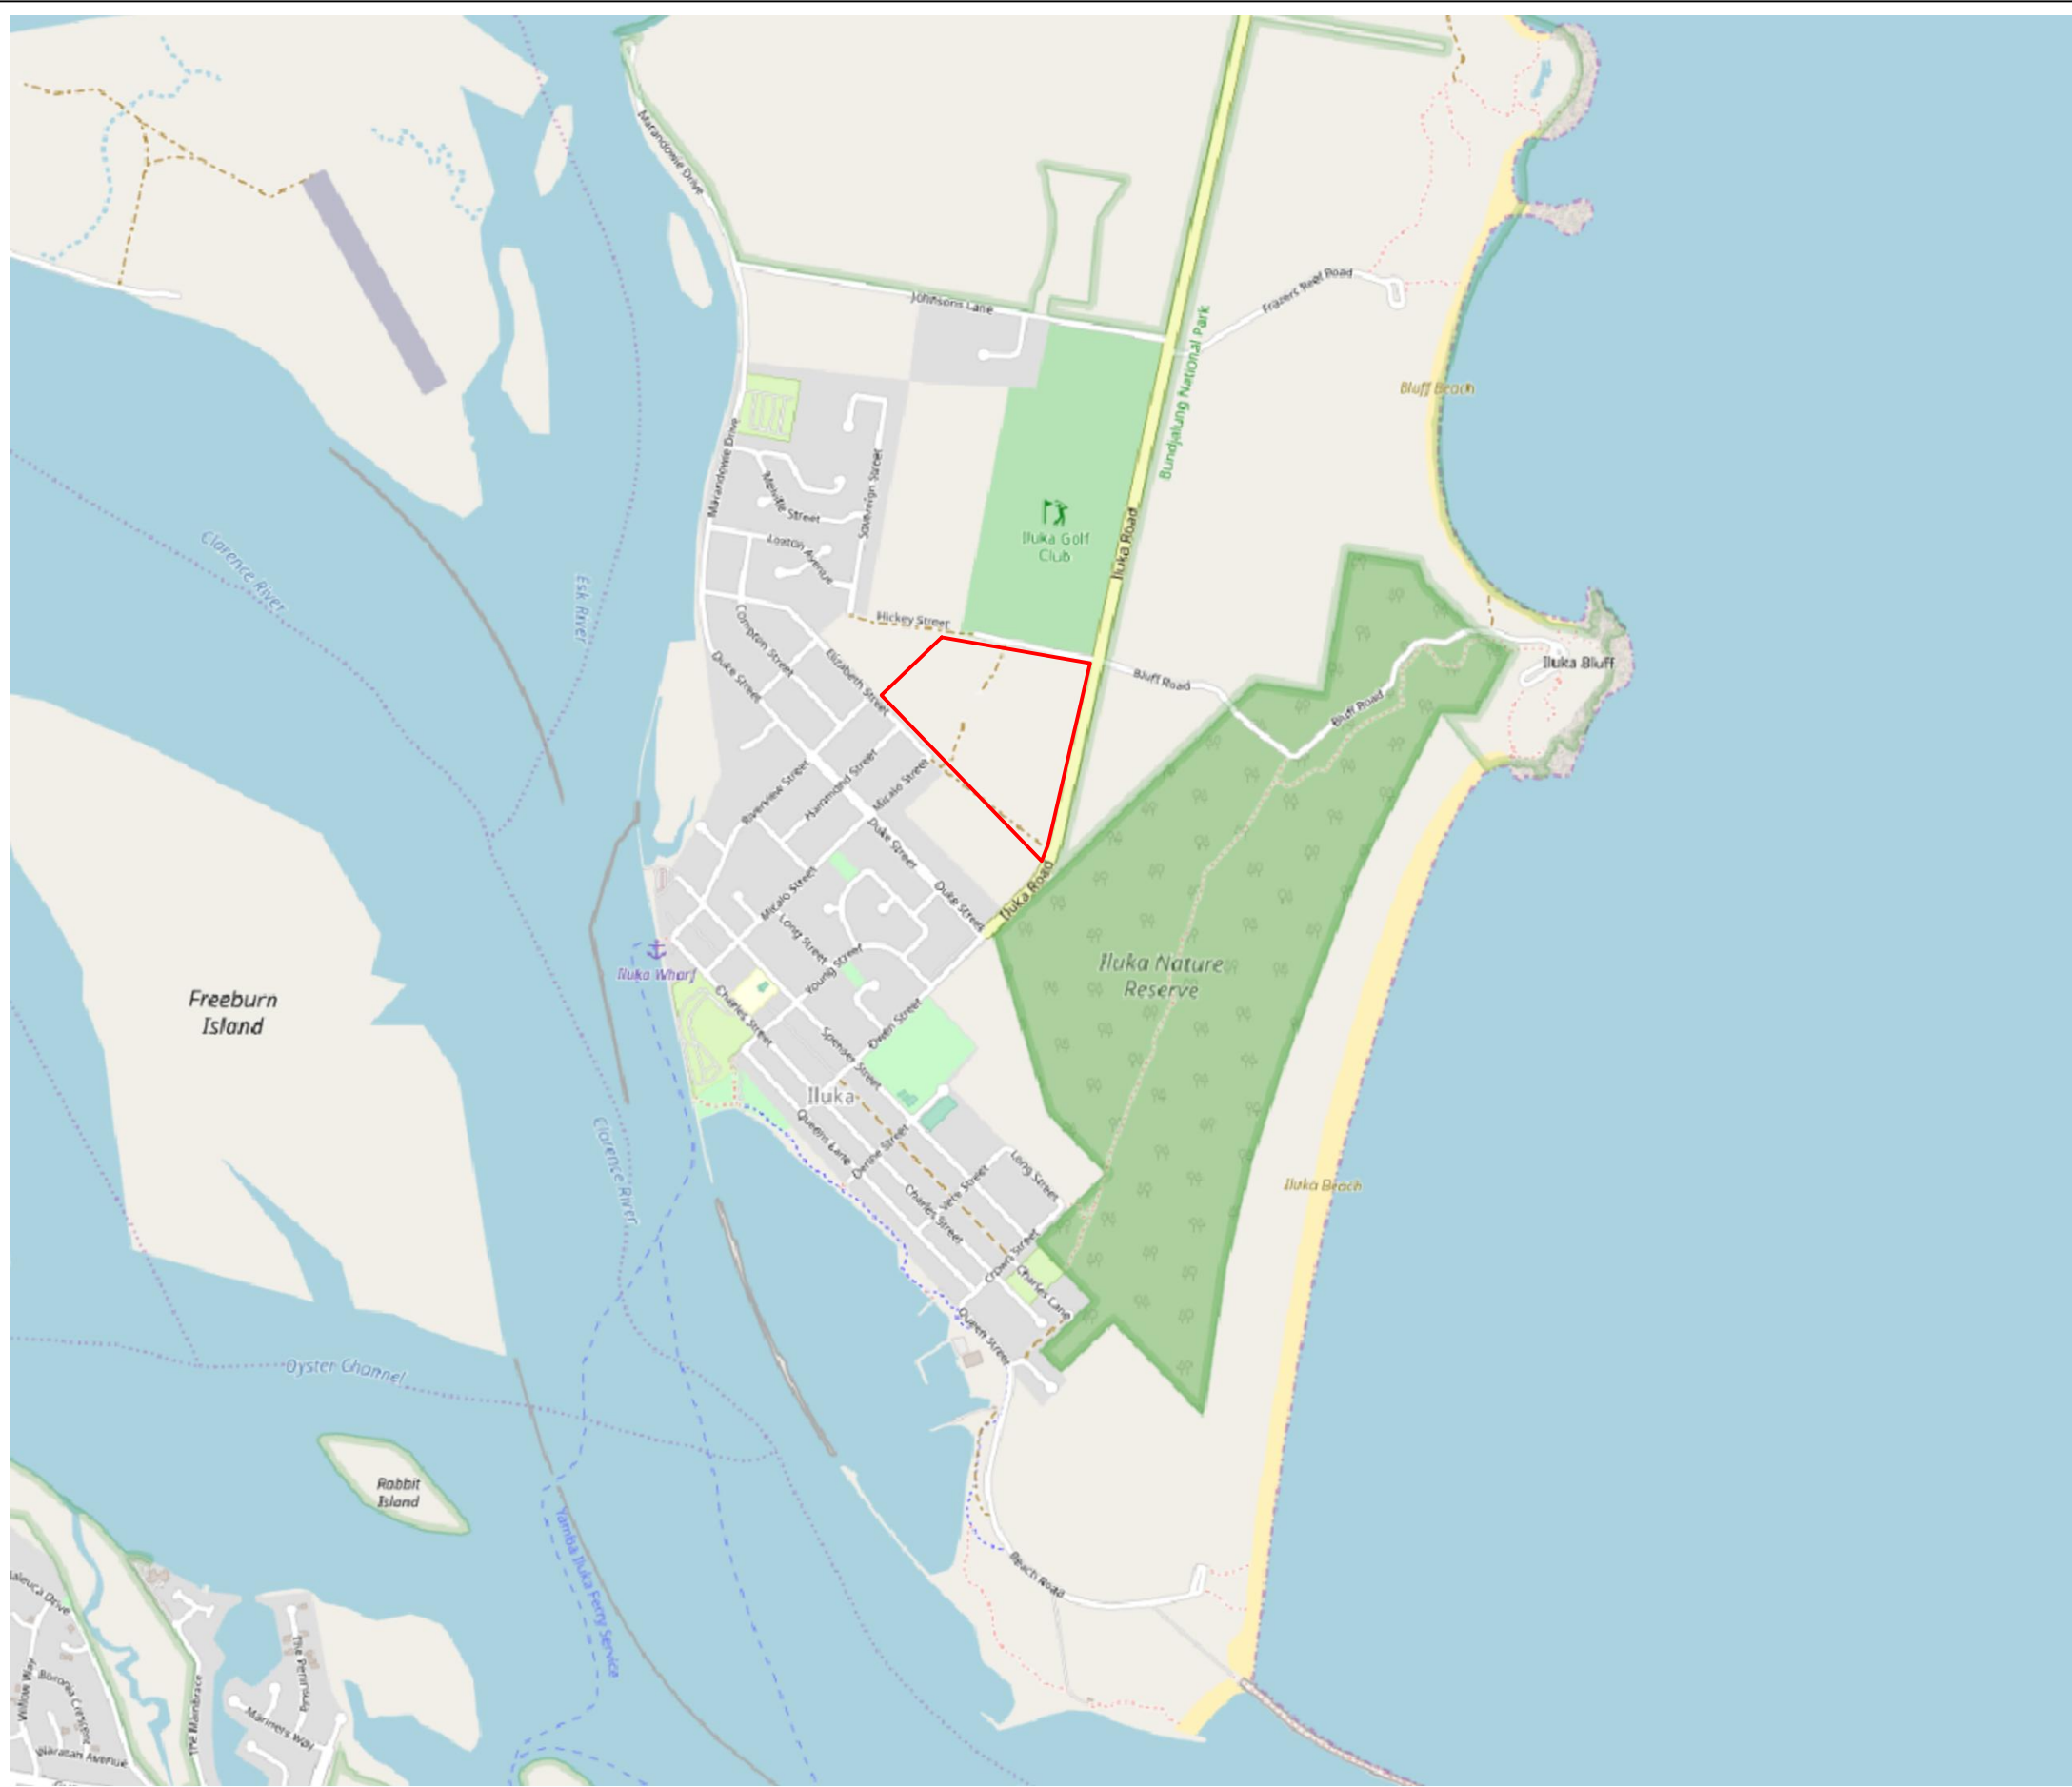
SOURCE: OneCollective - Masterplan (191113 CVC Approved Plans - Extract.pdf)	CLIENT Ocean Park Consulting Pty Ltd	FIGURE 1	TITLE APPROVED MASTER PLAN
SCALE: 1 : 2500 @ A3	PROJECT Baseline Koala Monitoring Report Birrigan Estate Lot 99 on DP823635, Hickey Street, Iluka NSW Clarence Valley Council LGA		
JWA PTY LTD Ecological Consultants		PREPARED: BW DATE: 02 June 2020 FILE: N202001_SAT_20200302.dwg

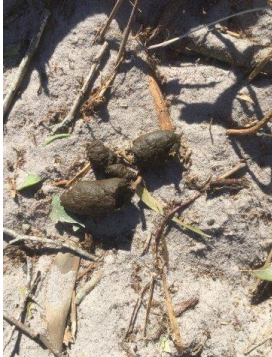
Date	Fauna / Habitat Feature	Tree Species	DBH (m)	Height (m)	Hollows	GPS	Details	Photos
23/08/21	Fresh wallaby scats in clearing area

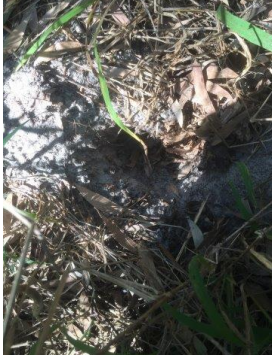
23/08/21	Numerous cone-shaped fauna diggings typical of bandicoot

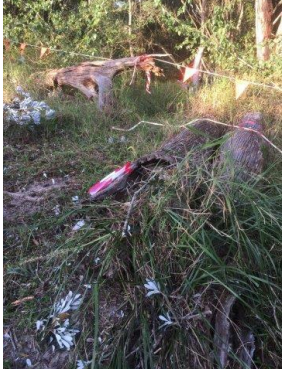
Date	Fauna / Habitat Feature	Tree Species	DBH (m)	Height (m)	Hollows	GPS	Details	Photos
24/08/21	4x flagged hollow fallen ground logs and log piles						Clearing surrounding vegetation and exposed log piles left for 48 hours to allow any occupying fauna to relocate. 2 substantially hollow logs able to be moved to environmental protection zone without breaking up due to decay

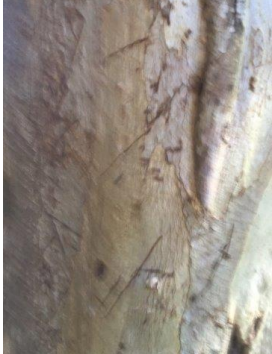
24/08/21	Fauna scratch marks typical of Lace Monitor on several smooth barked trees	<i>Eucalyptus tereticornis</i> Forest Red Gum

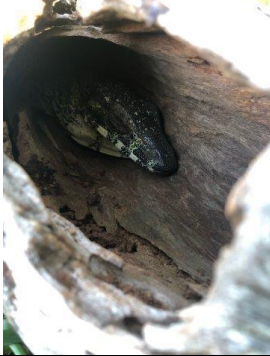
Date	Fauna / Habitat Feature	Tree Species	DBH (m)	Height (m)	Hollows	GPS	Details	Photos
25/08/21	Stag/ dead standing tree with Lace Monitor in spout			9m	Hollow stem and 3 small to medium sized hollow branches/ spouts	S 29.39980567 E 153.3561492	Relocated to environmental protection zone intact with Lace Monitor unharmed

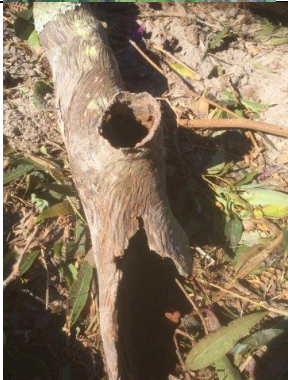
01/09/21	Small branch hollows relocated to environmental protection zone as potential habitat

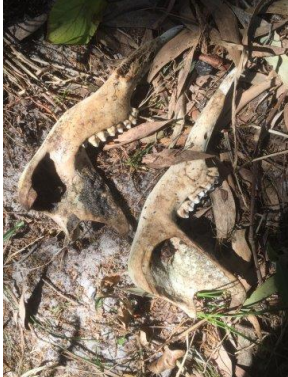
Date	Fauna / Habitat Feature	Tree Species	DBH (m)	Height (m)	Hollows	GPS	Details	Photos
01/09/21	Wallaby jaws found in clearing area

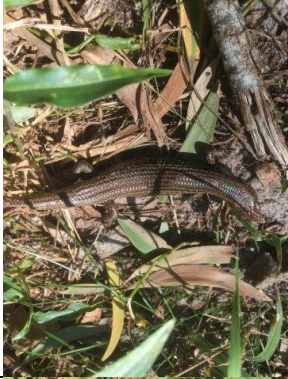
03/09/21	Major Skink relocated from clearing area to environmental protection zone

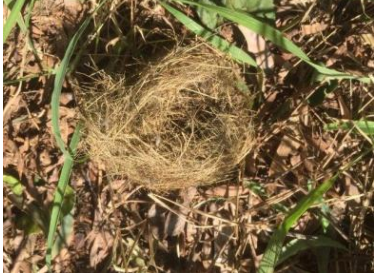
03/09/21	Vacant disused small bird's nest from wattle						Nest in wattle was gently lowered to allow inspection. No fauna or eggs present. Nest relocated to environmental protection zone

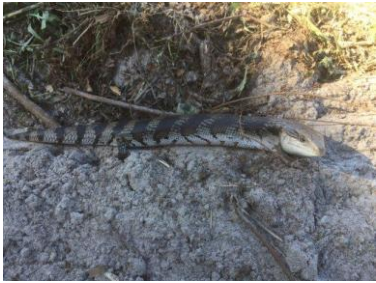
Date	Fauna / Habitat Feature	Tree Species	DBH (m)	Height (m)	Hollows	GPS	Details	Photos
03/09/21	2x adult Eastern Blue-tongue Lizards relocated from clearing area to environmental protection zone

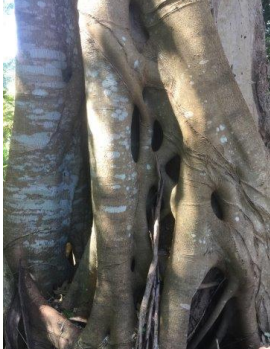
6/09/21	Small vacant hollows in coalescent fig roots inspected prior to tree removal	<i>Ficus watkinsiana</i> Watkin's Fig		14m

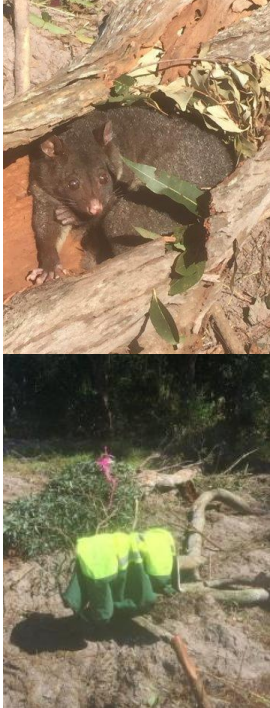
Date	Fauna / Habitat Feature	Tree Species	DBH (m)	Height (m)	Hollows	GPS	Details	Photos
6/09/21	Stag/ dead standing tree gently lowered revealing unharmed Common Brushtail Possum following partial break of main stem			9m	Large stem hollow and 2 small to medium sized upper hollow branches/ spouts	S 29.39938 E 153.35669	Stag undisturbed for 48 hours and bulk branches applied over possum occupied section for dense shade to allow possum to self-relocate in the evening (confirmed self-relocation on 8/9/21). Hollow stem relocated to environmental protection zone

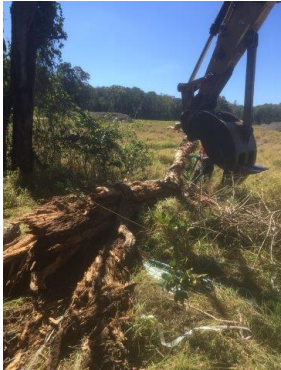
Date	Fauna / Habitat Feature	Tree Species	DBH (m)	Height (m)	Hollows	GPS	Details	Photos
6/09/21	HT 21 Stag/ dead standing tree			9m	3 small to medium sized upper hollow branches/ spouts	S 29.39950 E 153.35661		
7/09/21	HT 6. Stag/ dead standing tree				Stem hollow and 3 small sized upper hollow branches/ spouts	S 29.39962 E 153.35614	Active Tree Termites ( <i>Nasutitermes walkeri</i> )	
7/09/21	Dead Broad-leaved Paperbark with cultural significance relocated from vegetation adjoining Elizabeth Street to environmental protection zone	Dead <i>Melaleuca quinquenervia</i> Broad-leaved Paperbark			Large main stem hollow		No occupying fauna observed in hollowed sections

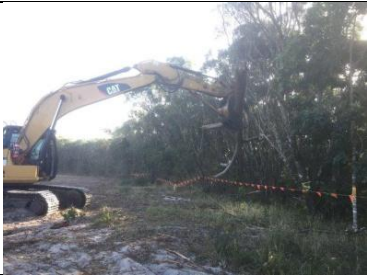
Date	Fauna / Habitat Feature	Tree Species	DBH (m)	Height (m)	Hollows	GPS	Details	Photos
8/09/21	Stag/ dead standing tree			7m	Large stem hollow and 3 medium sized upper hollow branches/ spouts	S 29.39931 E 153.35629	Relocated to environmental protection zone

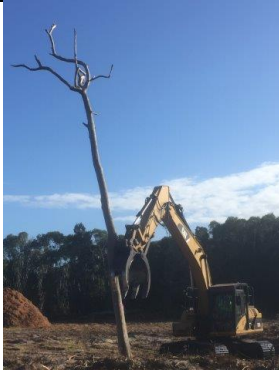
8/09/21	Stag/ dead standing tree			6m	Large stem hollow open at top	S 29.39928 E 153.35640	Highly decayed and unable to be relocated to environmental protection zone	
8/09/21	Stag/ dead standing tree			11m	Stem hollow and 3 small spouts at top	S 29.39899 E 153.35660	Relocated to environmental protection zone

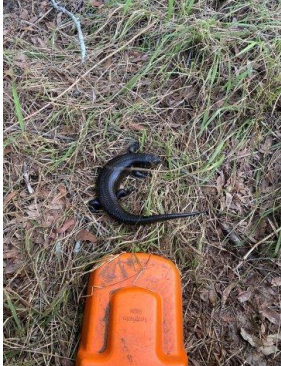
Date	Fauna / Habitat Feature	Tree Species	DBH (m)	Height (m)	Hollows	GPS	Details	Photos
9/09/21	Mature Land Mullet						Detected by machine operator following completion of clearing and relocated to environmental protection zone unharmed

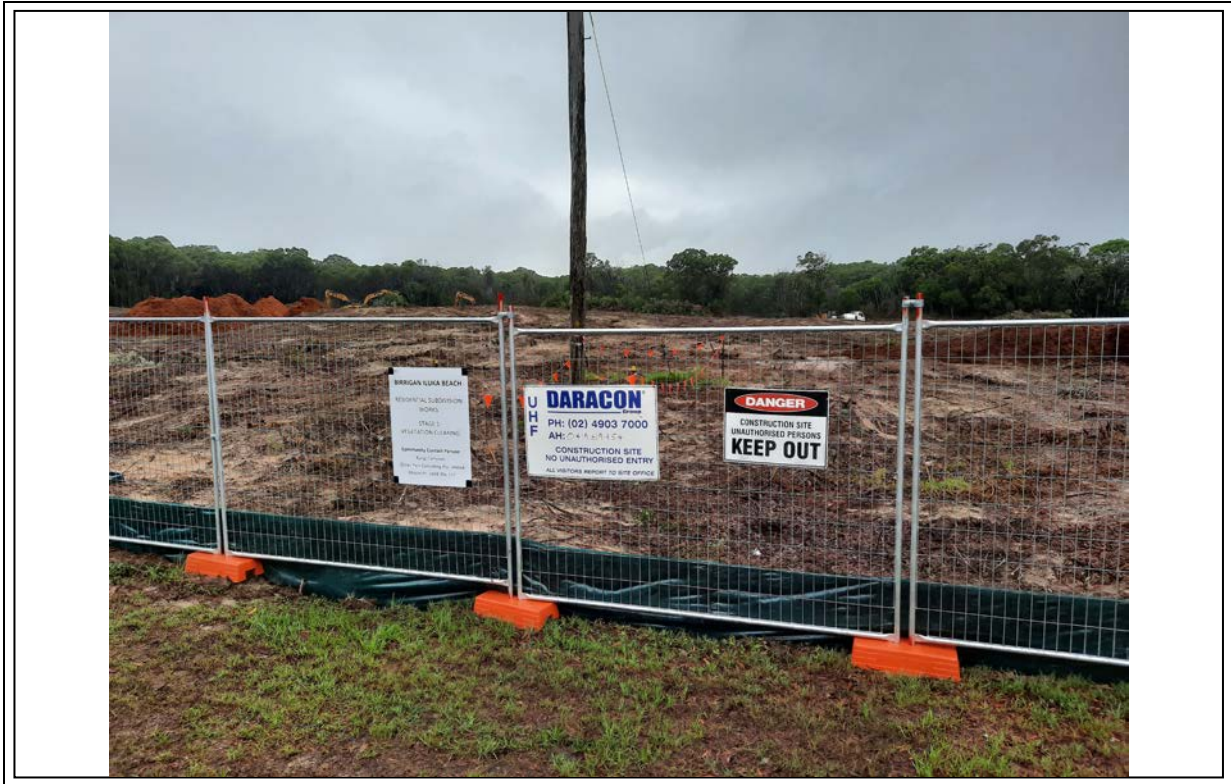
**Photo 1:** Wood chip operation in progress. Looking from Micalo + Elizabeth Street intersection to the project site.

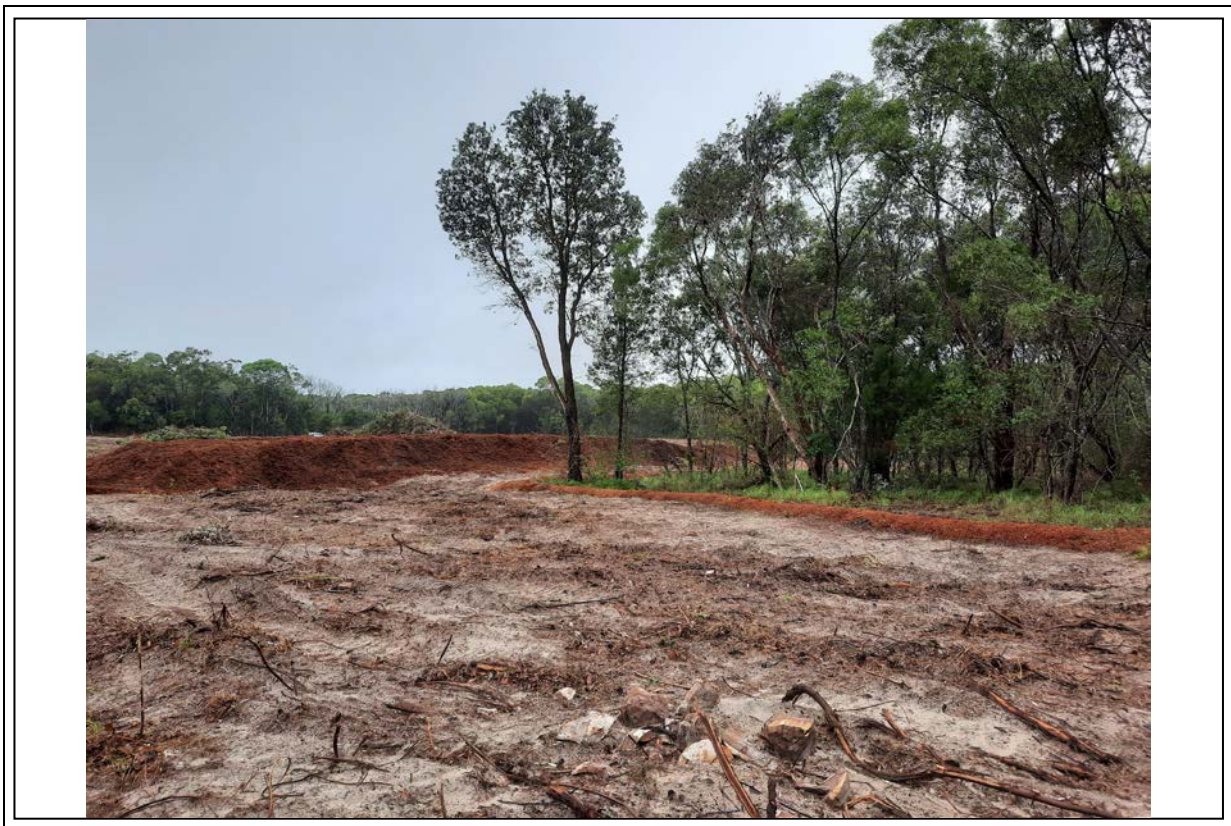
**Photo 2:** Wood chip stockpile north of Lot 1 Park C + F. Wood chip mulch berm to Lot 1 perimeter.

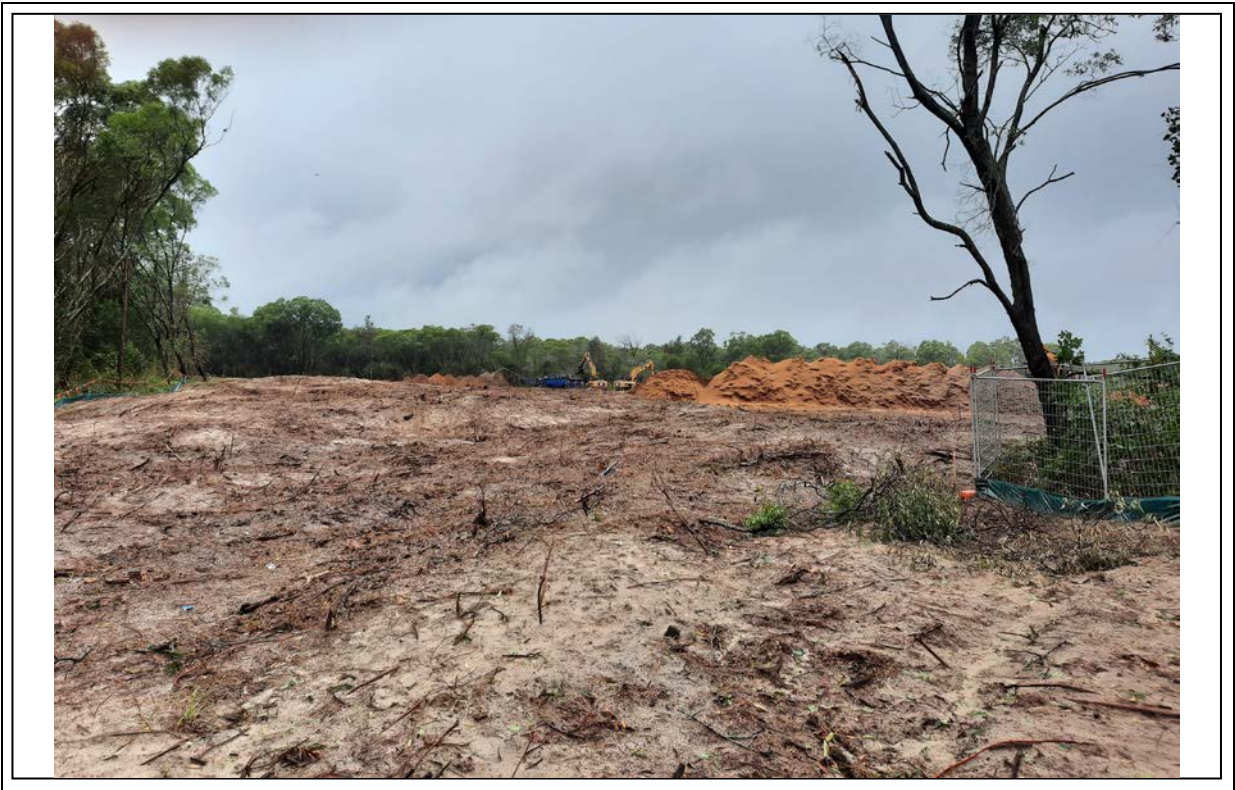
**Photo 3:** Excavators feeding wood chip grinder on western portion of Stage 1 looking from Elizabeth Street future emergency access position.

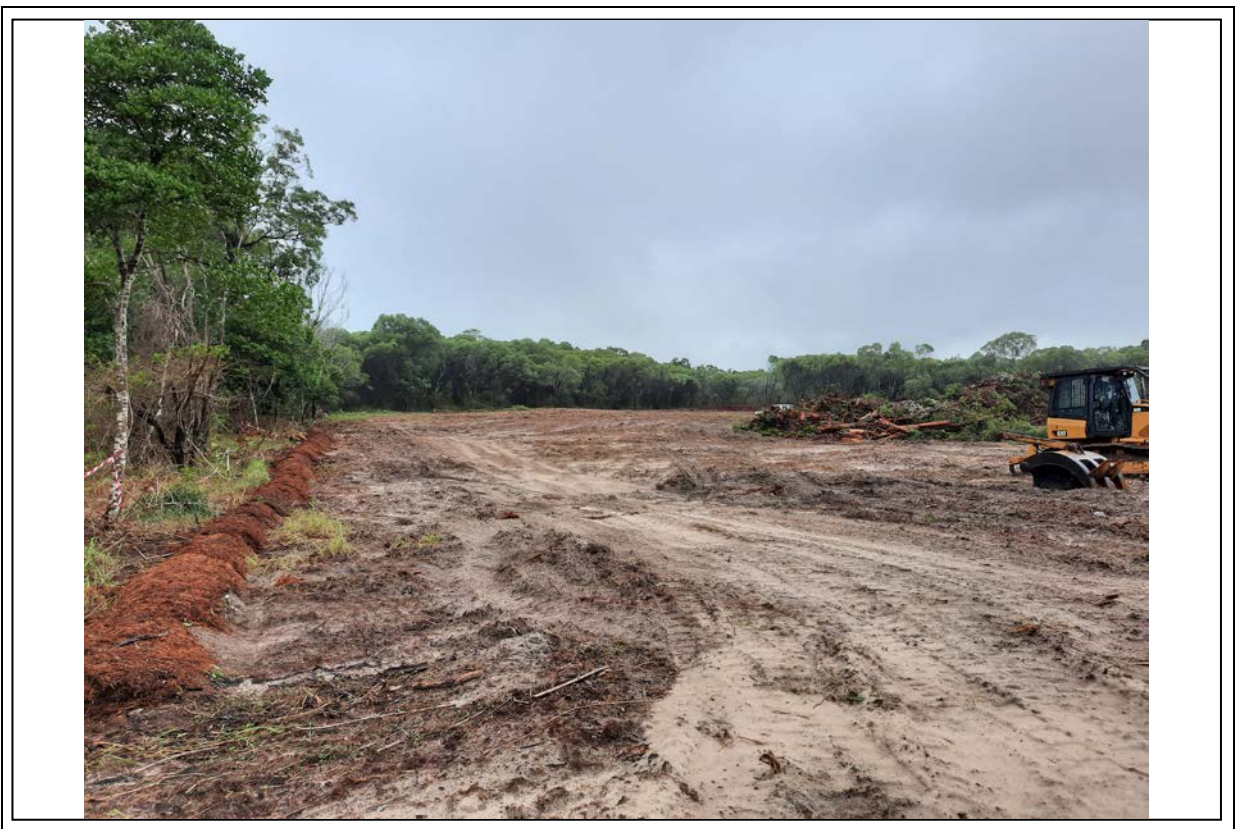
**Photo 4:** Wood chip / mulch berm to edge of vegetation clearing along north / eastern internal boundary taken from existing access track.

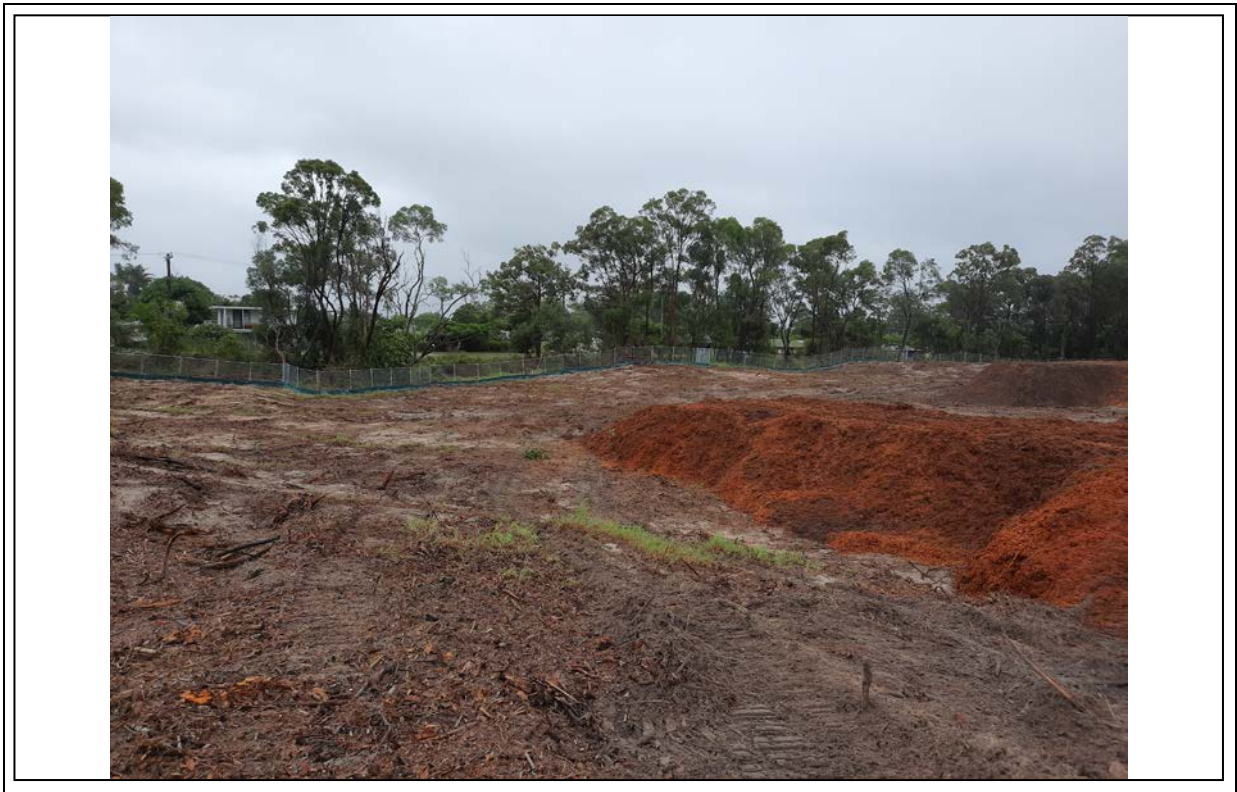
**Photo 5:** “Green vegetation shoots” coming through, wood chip stockpiles looking south towards Elizabeth Street just to west of Micalo Street intersection.

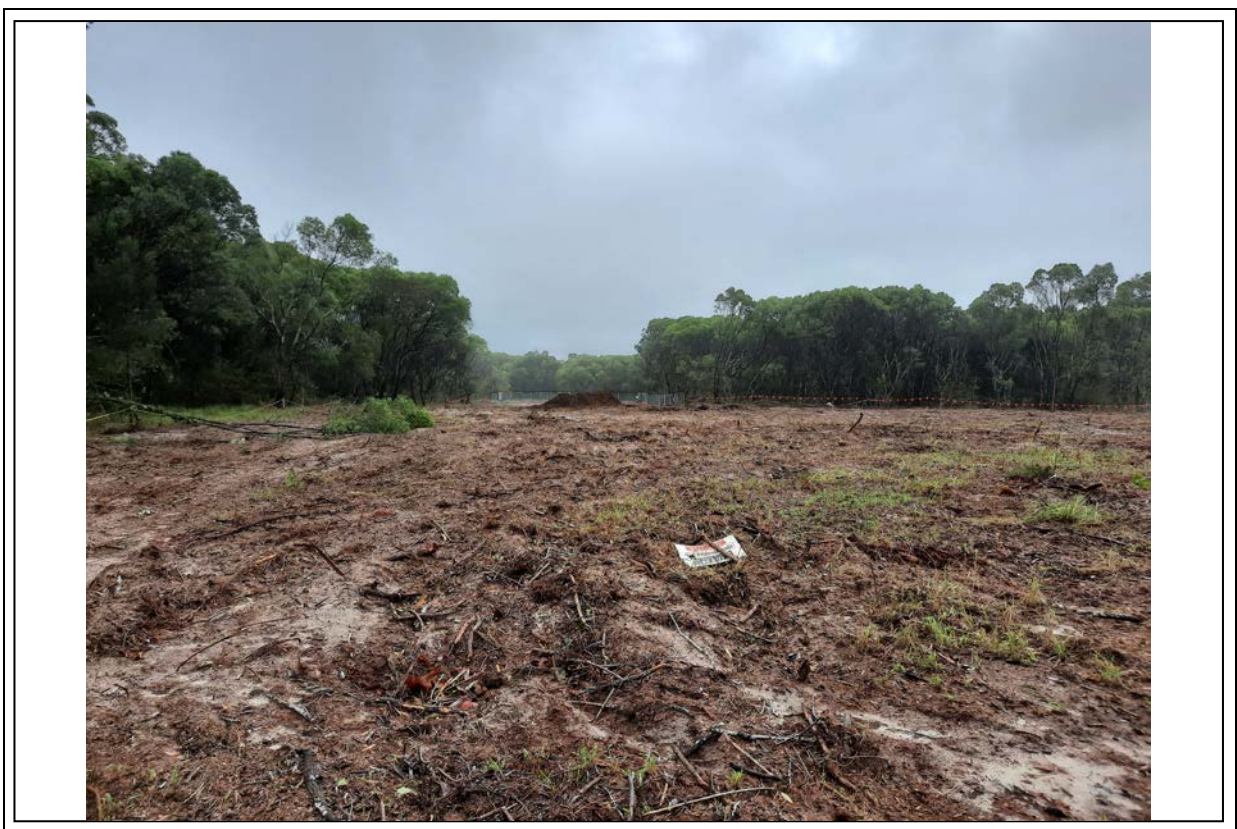
**Photo 6:** From northern Stage 1 clearing boundary looking south towards existing bushfire trail fence behind stockpile and Lot 1 (Park C) partly behind fence + part red flag demarcation.

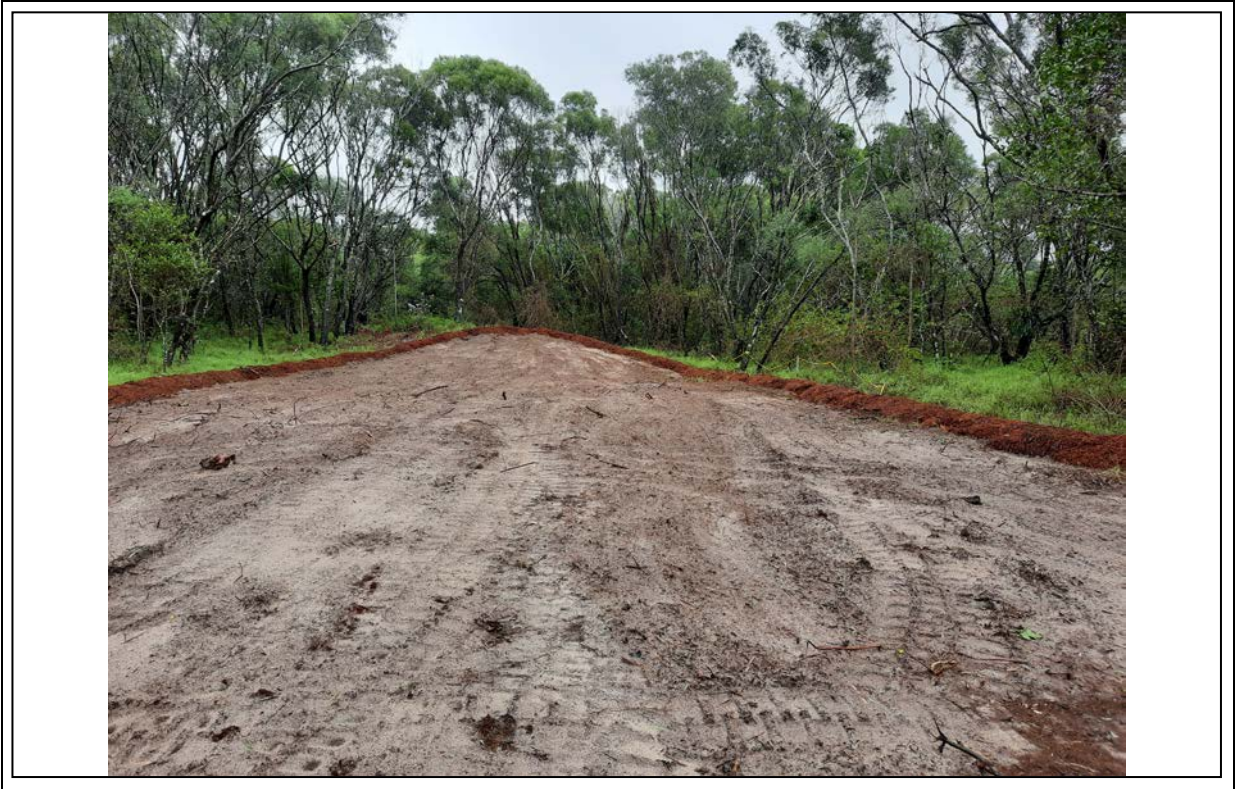
**Photo 7:** Wood chip / mulch berm to perimeter of construction compound area off Lot 7020 + Hickey Street.

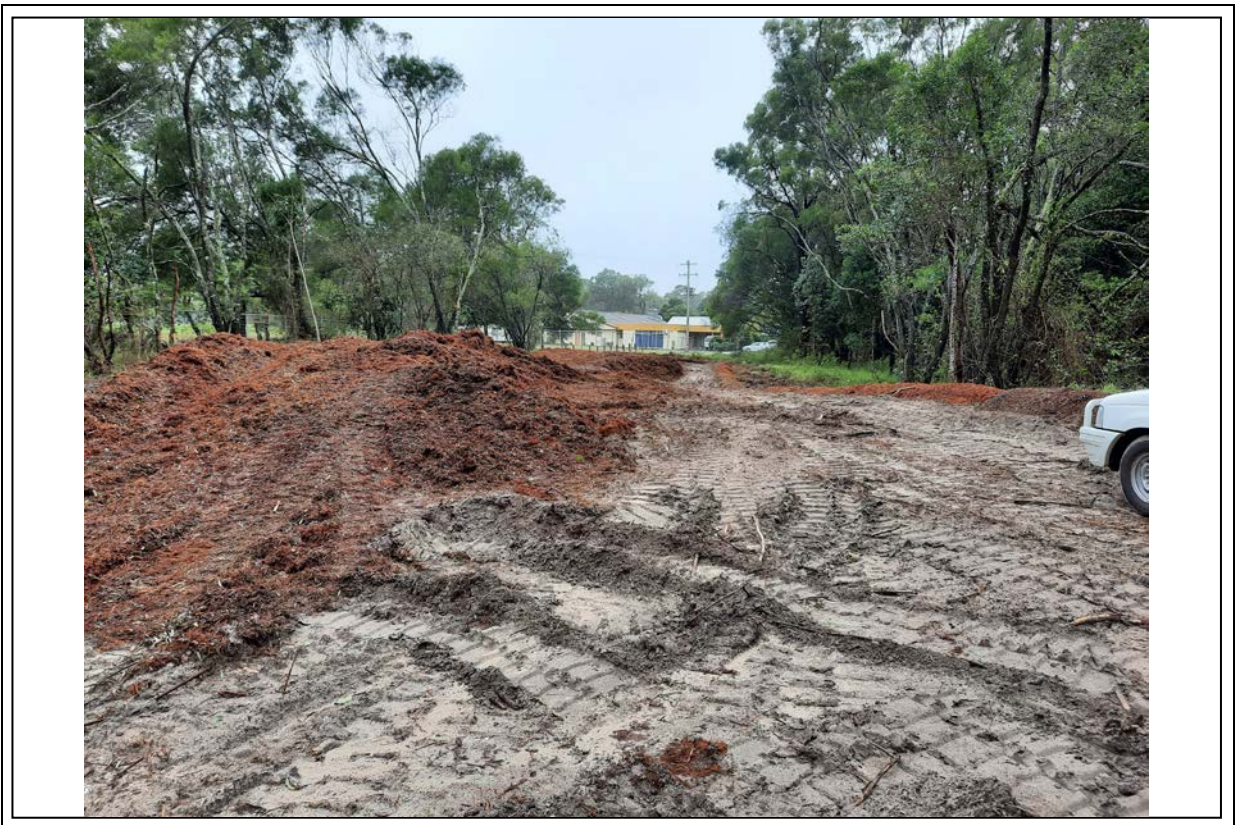
**Photo 8:** Wood chip / mulch stockpile + berm to perimeter access to Hickey Street looking from site towards Iluka Golf Club.
